Maritec Tanker Management Incident Reports Details

Vessel: Bitu Atlantic Defect ID: 264 NCR #: 3/2023 Is NCR ?: Yes

Defect Details

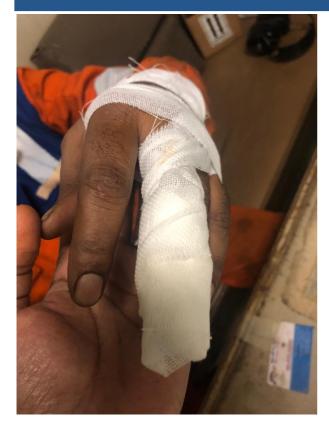
Before

Fitter Mr.Acchelal while removing spool piece from the Scrubber sea water line, the Spool piece fall on his left hand middle finger and injured with small cut.

Work was stopped immediately, first aid was given to the person involved.

Retraining to be carried out, the job must supervise by engineers
