Maritec Tanker Management

Incident Report's Details

Vessel : Bitu Atlantic	Defect ID : 264	NCR # : 3/2023	Is NCR ? : Yes
------------------------	-----------------	----------------	----------------

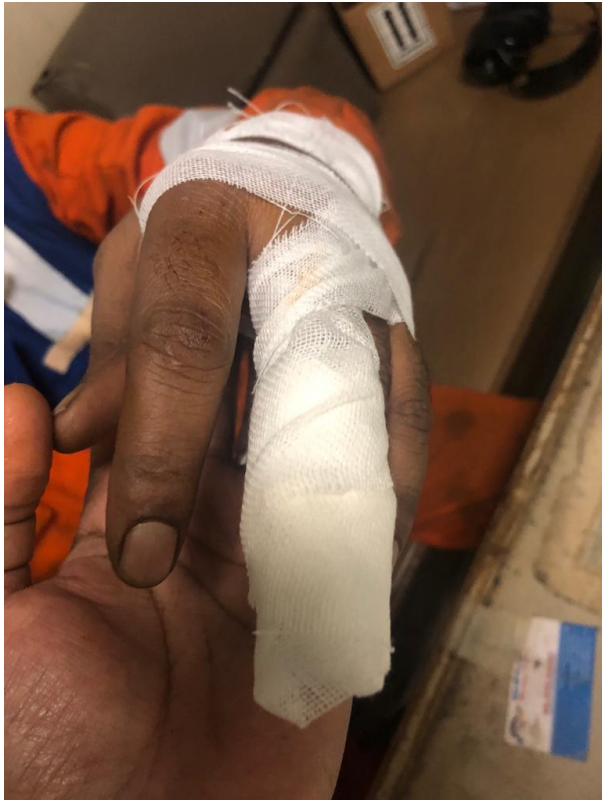
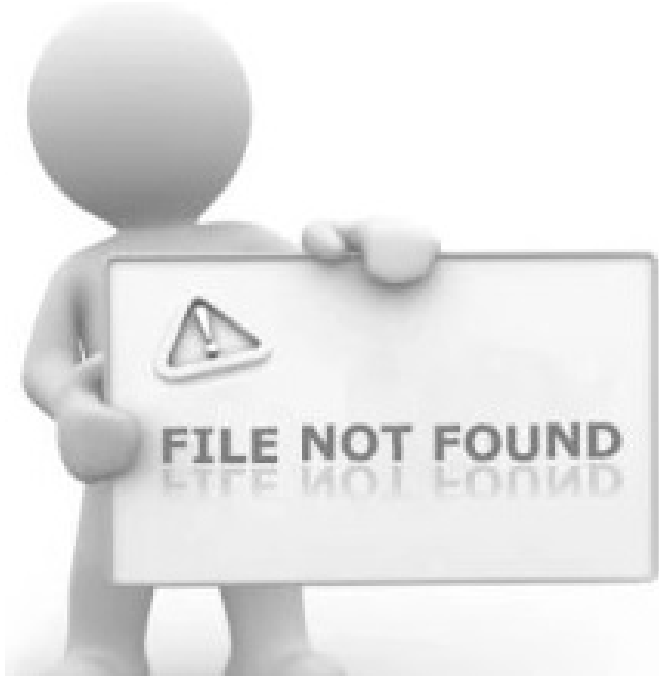
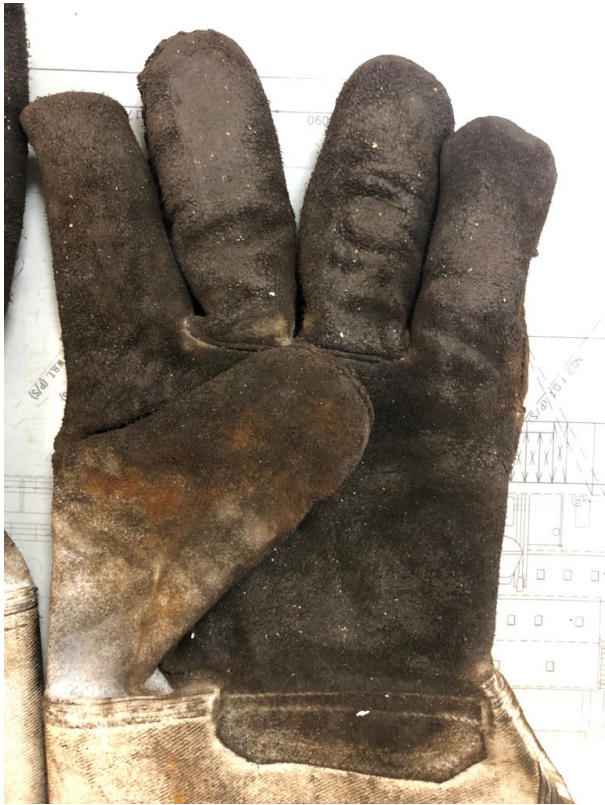
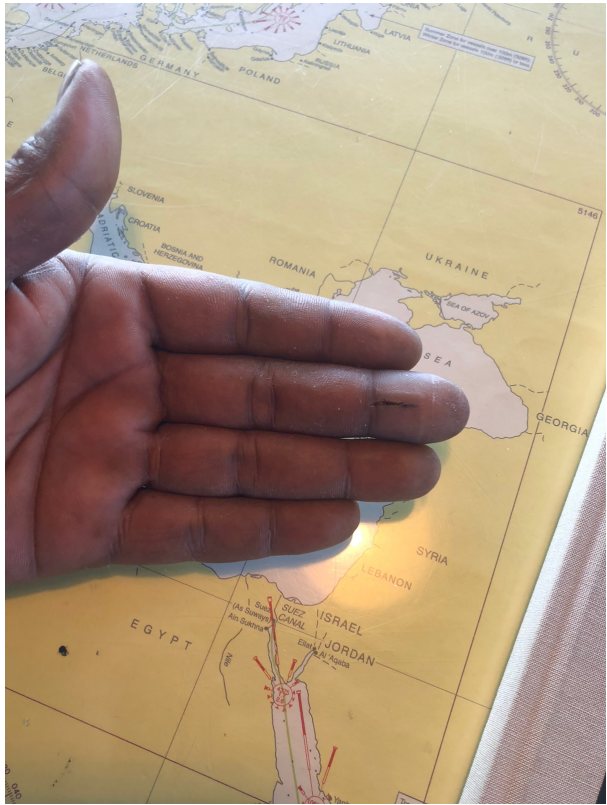
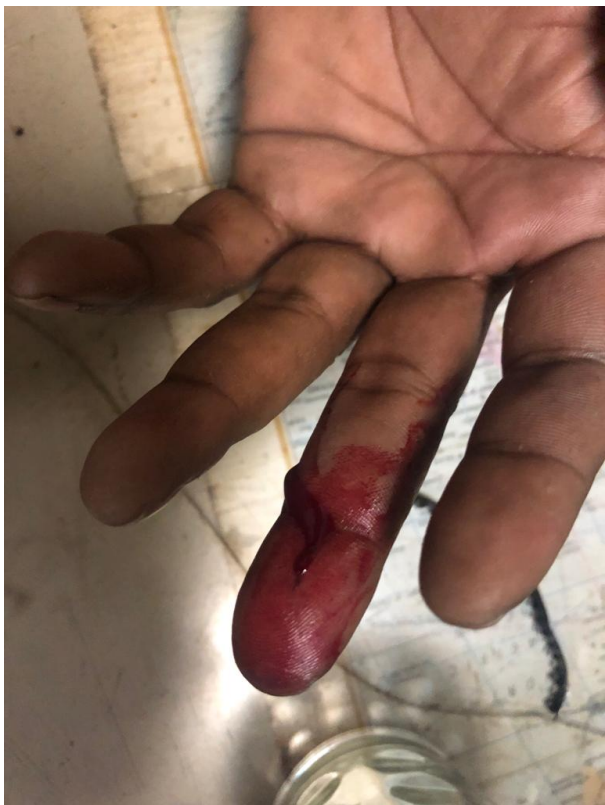
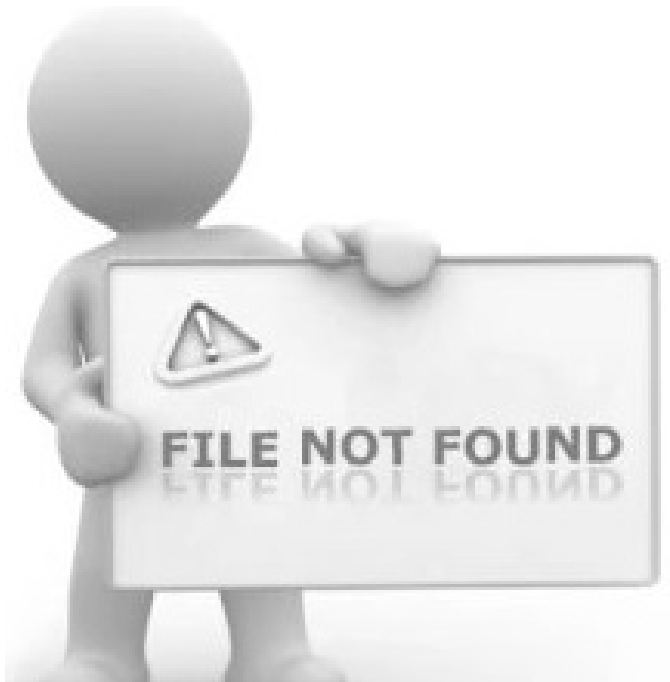
Fitter Mr.Acchelal while removing spool piece from the Scrubber sea water line, the Spool piece fall on his left hand middle finger and injured with small cut.

Uncoordination of workers during the job

Work was stopped immediately, first aid was given to the person involved.

Retraining to be carried out , the job must supervise by engineers
