Maritec Tanker Management

Incident Reports Details

Vessel : Bahama Blue	Defect ID : 186	NCR # : 8/2023	Is NCR ? : Yes
----------------------	-----------------	----------------	----------------

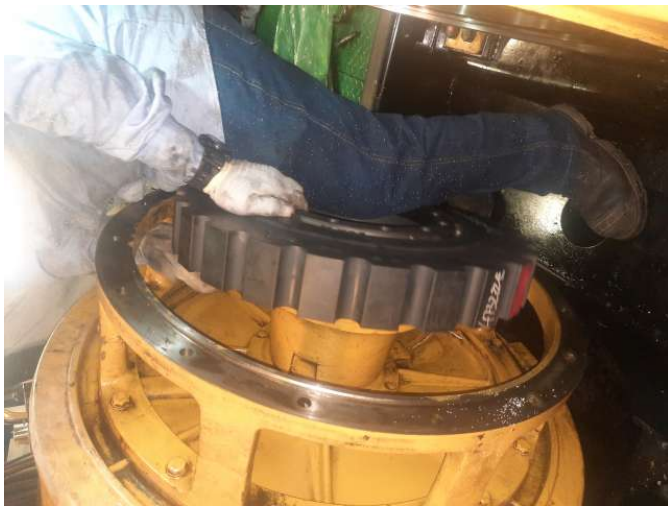
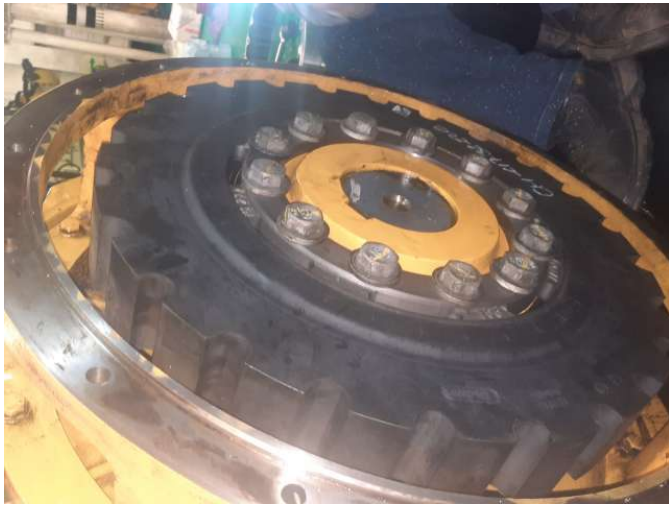
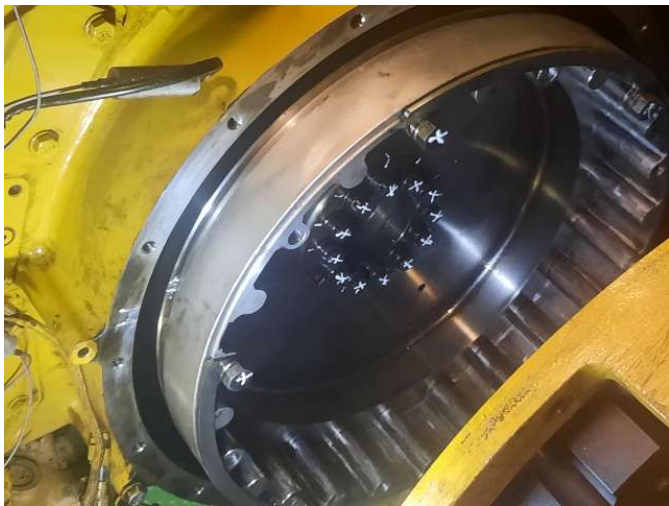
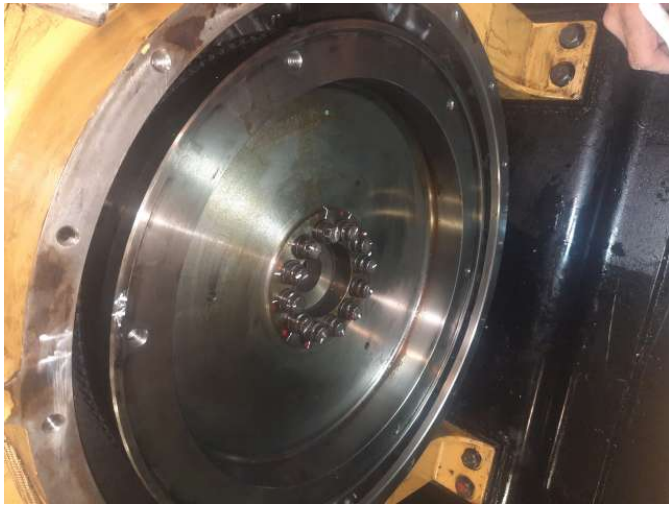
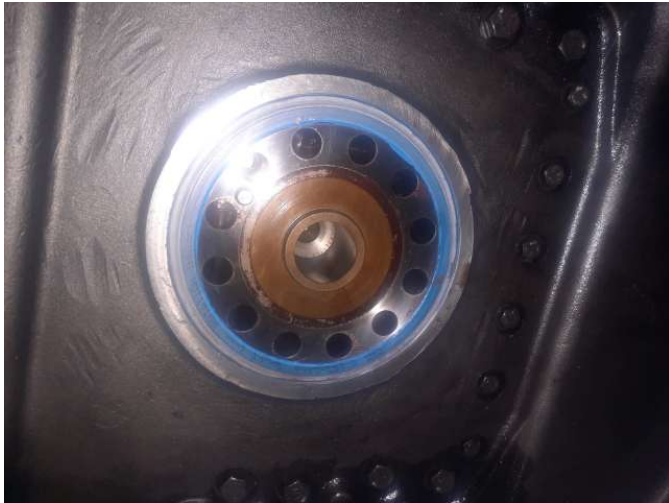
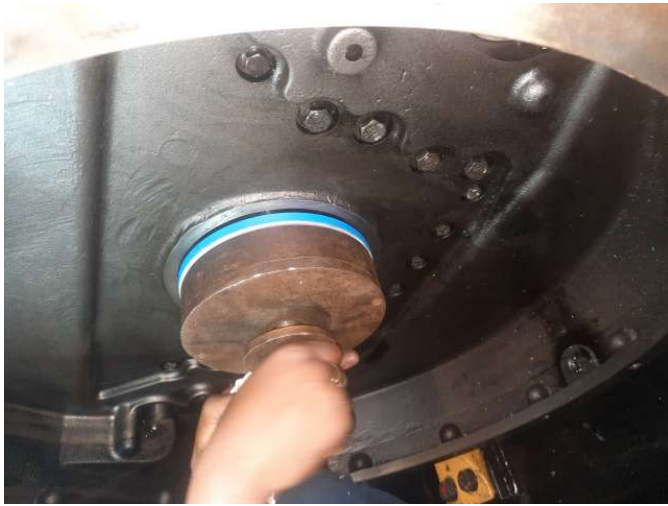
Initial reason for malfunction AE No.2 was damaged rubber coupling on between alternator and engine.
Damage of rubber coupling caused by leaking luboil on shaft seal and high temprature of air in the Engine Room.
During repair for replacing rubber coupling observed that alternator shaft is not free spinning.
AE no.2 Alternator was contaminated inside by oil form leaking shaft seal.
This caused by overheating of forward bearing of Alternator AE No.2 as it was checked for internal memory parameters by controller connected to PC of MACORP Technician.

Repair done to replace shaft seals and rubber coupling.
Repair for Alternator AE No.2 arranged in Trinidad upon arrival vessel on 18.06.2023.
