Maritec Tanker Management Private Limited

Incident Reports Details

Vessel : Bahama Blue	Defect ID : 186	NCR # : 8/2023	Is NCR ? : Yes
----------------------	-----------------	----------------	----------------

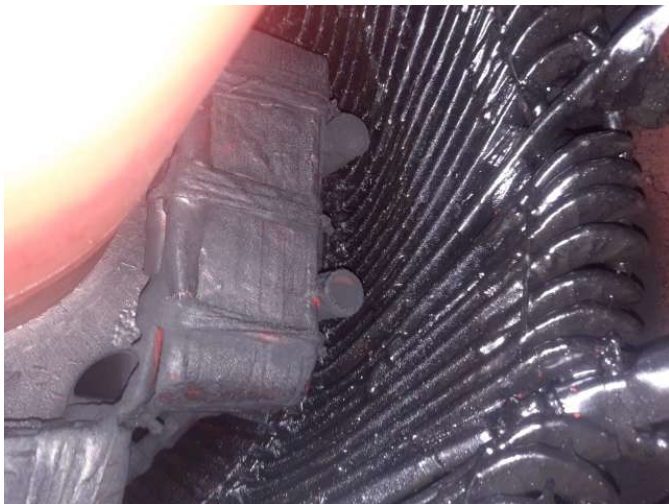
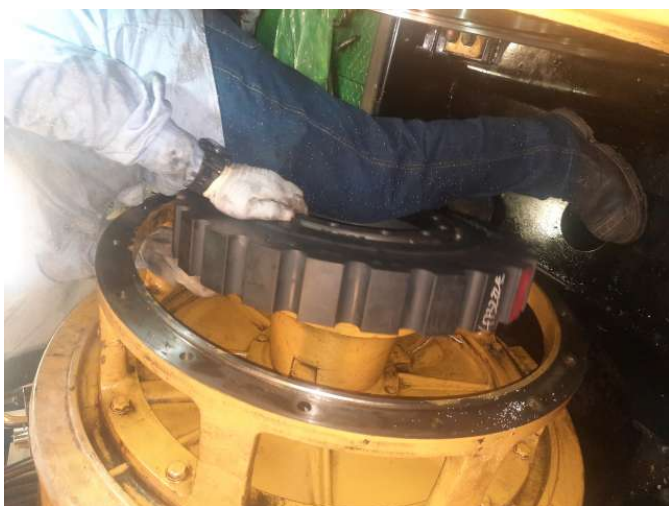
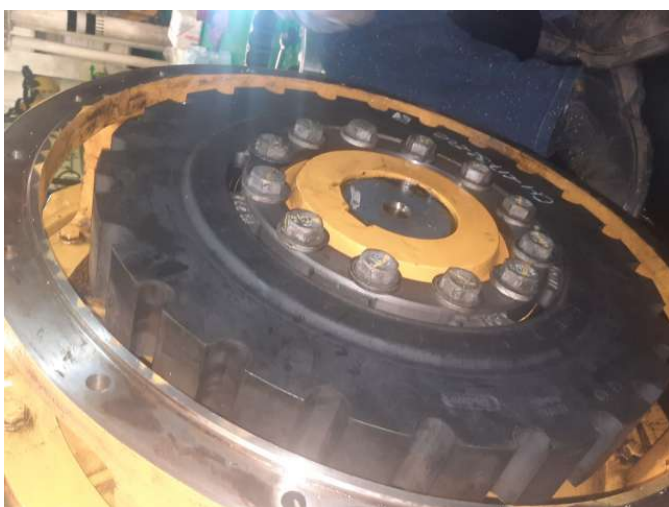
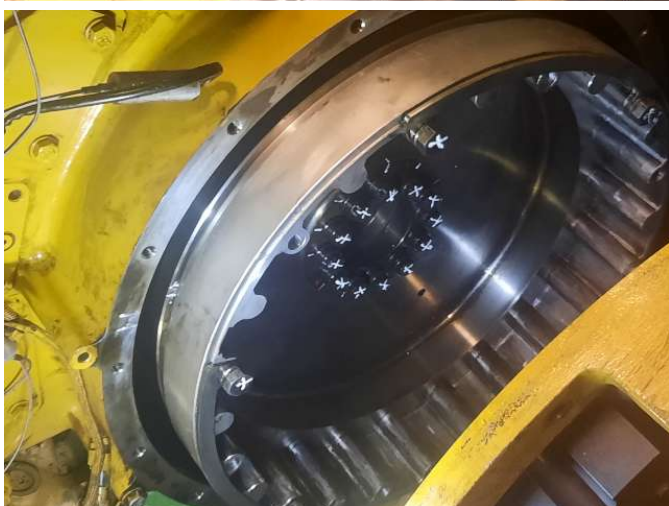
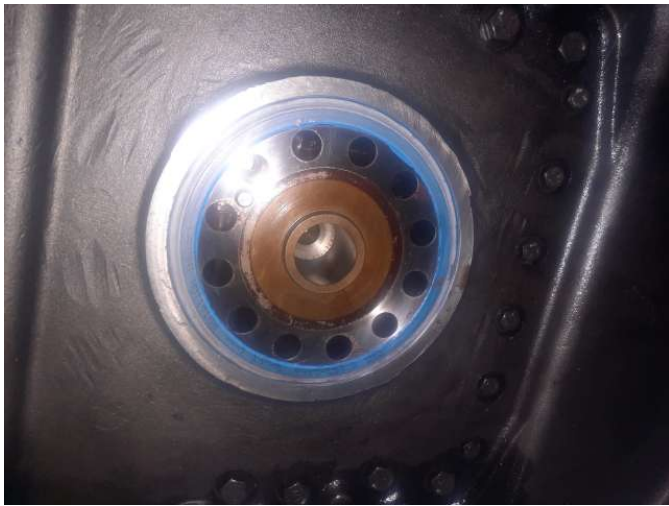
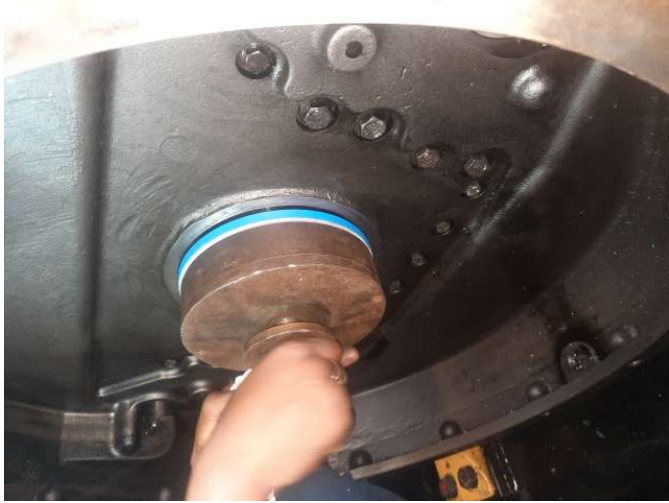
Initial reason for malfunction AE No.2 was damaged rubber coupling on between alternator and engine.
Damage of rubber coupling caused by leaking luboil on shaft seal and high temprature of air in the Engine Room.
During repair for replacing rubber coupling observed that alternator shaft is not free spinning.
AE no.2 Alternator was contaminated inside by oil form leaking shaft seal.
This caused by overheating of forward bearing of Alternator AE No.2 as it was checked for internal memory parameters by controller connected to PC of MACORP Technician.

Repair done to replace shaft seals and rubber coupling.
Repair for Alternator AE No.2 arranged in Trinidad upon arrival vessel on 18.06.2023.
