## Maritec Tanker Management Private Limited

### Incident Reports Details

Vessel : Bahama Blue	Defect ID : 186	NCR # : 8/2023	Is NCR ? : Yes
----------------------	-----------------	----------------	----------------

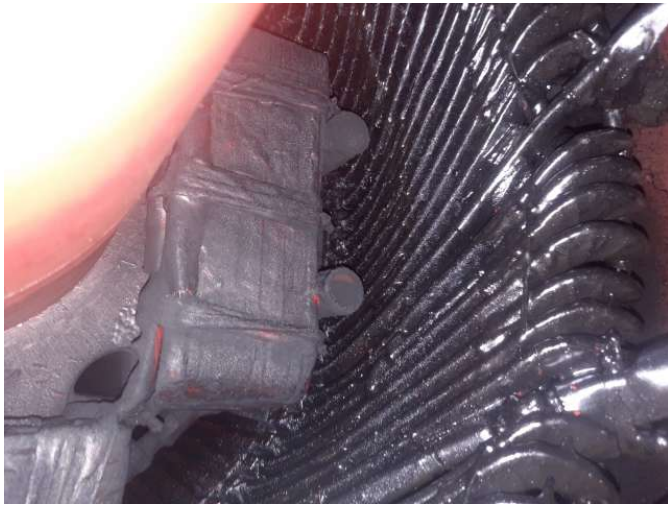
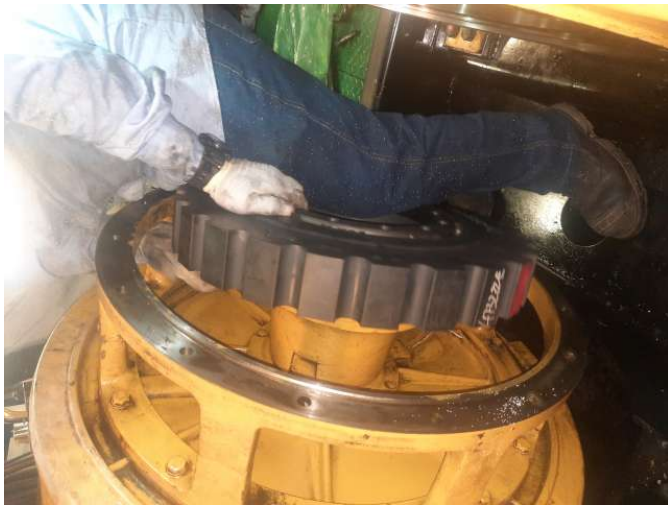
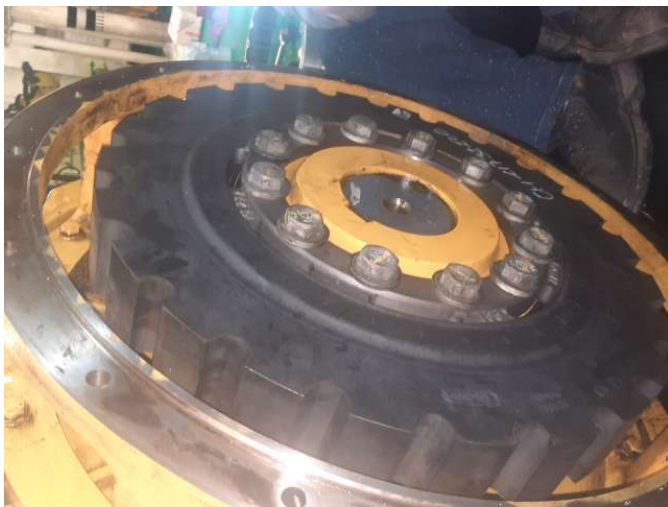
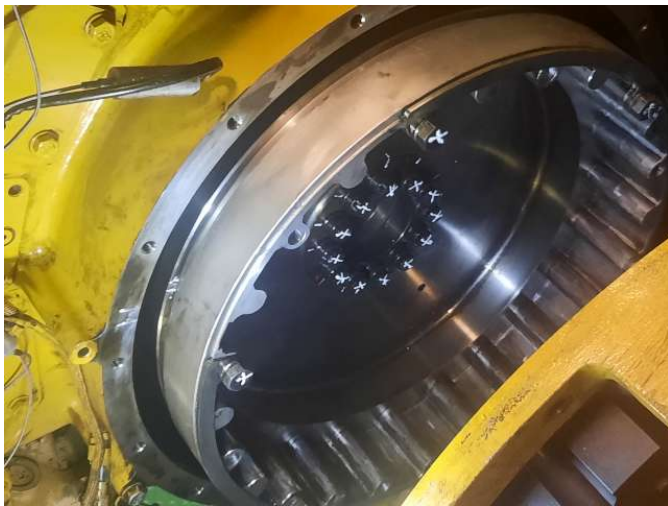
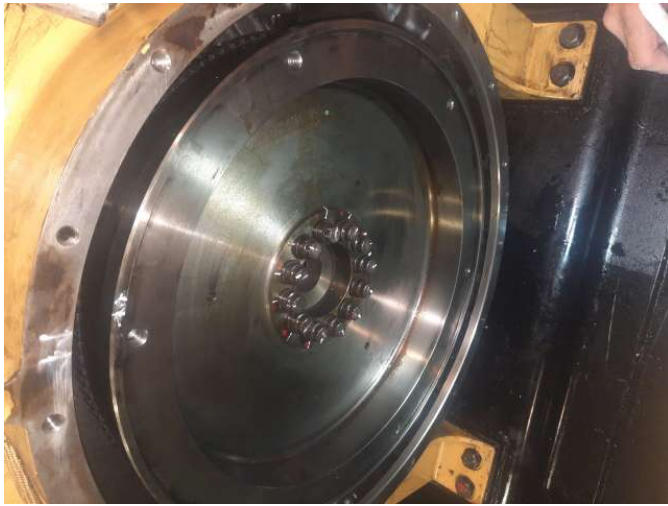
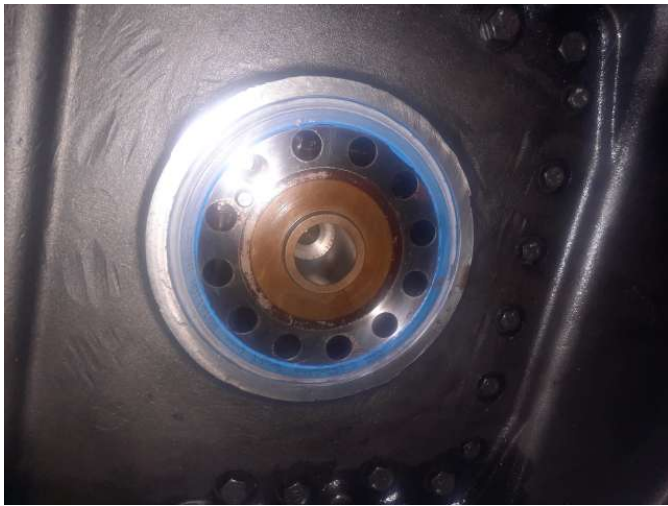
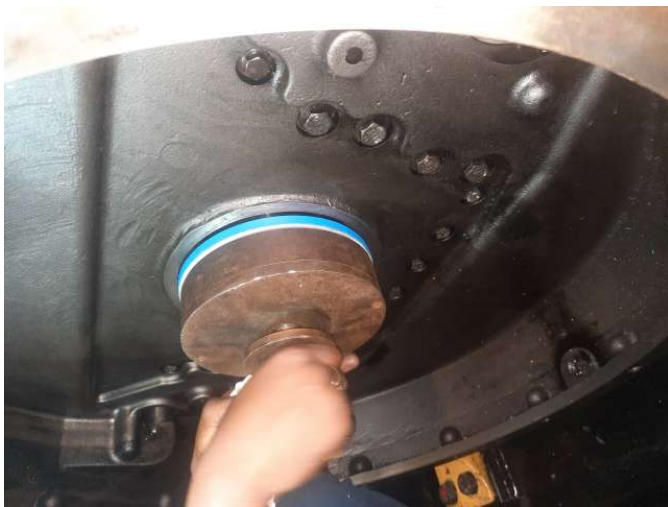
Vessel was enroute to Point e Pitre , Guadeloupe in ballast condition.  
 On 30-05-2023/15:15 during the voyage AE N.2 coupling failed and vessel had to be diverted as only AE No.1 Malfunction of AE No.2 caused reduction of power and vessel able to sail by speed about 3-4 knots only. Also Back-up power remaining only by Emergency Generator.

Initial reason for malfunction AE No.2 was damaged rubber coupling on between alternator and engine.  
 Damage of rubber coupling caused by leaking luboil on shaft seal and high temprature of air in the Engine Room.  
 During repair for replacing rubber coupling observed that alternator shaft is not free spinning.  
 AE no.2 Alternator was contaminated inside by oil form leaking shaft seal.  
 This caused by overheating of forward bearing of Alternator AE No.2 as it was checked for internal memory parameters by controller connected to PC of MACORP Technician.

Repair done to replace shaft seals and rubber coupling.  
 Repair for Alternator AE No.2 arranged in Trinidad upon arrival vessel on 18.06.2023.
