Maritec Tanker Management

Incident Reports Details

Vessel : Bahama Blue	Defect ID : 186	NCR # : 8/2023	Is NCR ? : Yes
----------------------	-----------------	----------------	----------------

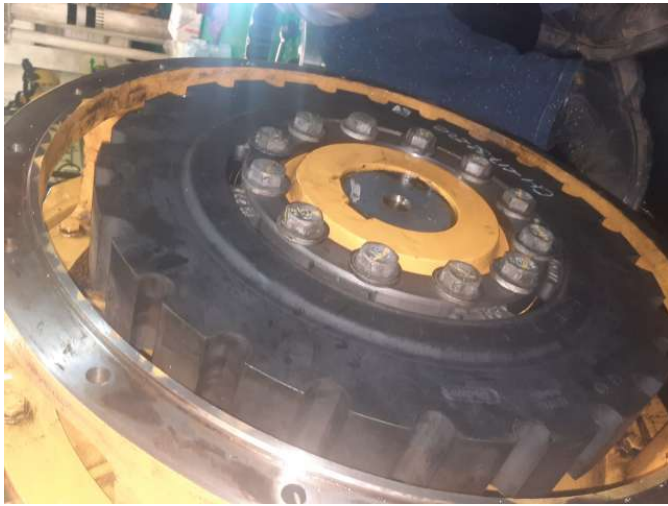
Initial reason for malfunction AE No.2 was damaged rubber coupling on between alternator and engine.
 Damage of rubber coupling caused by leaking luboil on shaft seal and high temprature of air in the Engine Room.
 During repair for replacing rubber coupling observed that alternator shaft is not free spinning.
 AE no.2 Alternator was contaminated inside by oil form leaking shaft seal.
 This caused by overheating of forward bearing of Alternator AE No.2 as it was checked for internal memory parameters by controller connected to PC of MACORP Technician.

Repair done to replace shaft seals and rubber coupling.
 Repair for Alternator AE No.2 arranged in Trinidad upon arrival vessel on 18.06.2023.
