Maritec Tanker Management Private Limited

Incident Reports Details

Vessel : Bahama Blue	Defect ID : 186	NCR # : 8/2023	Is NCR ? : Yes
----------------------	-----------------	----------------	----------------

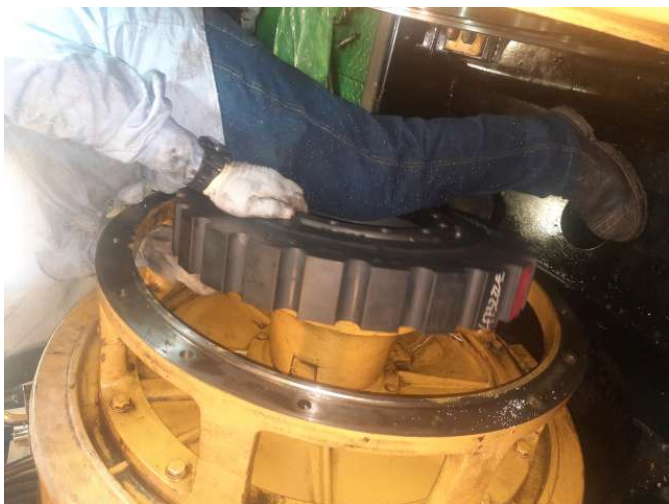
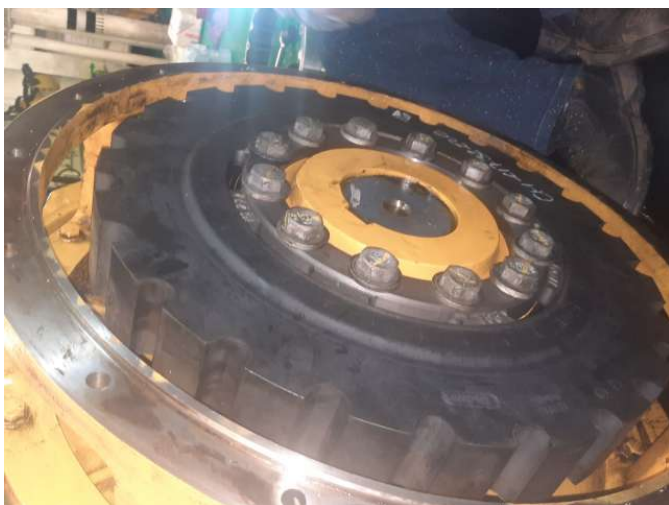
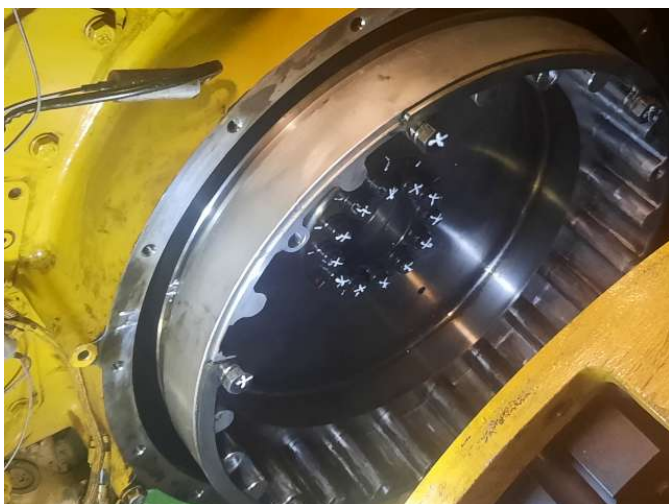
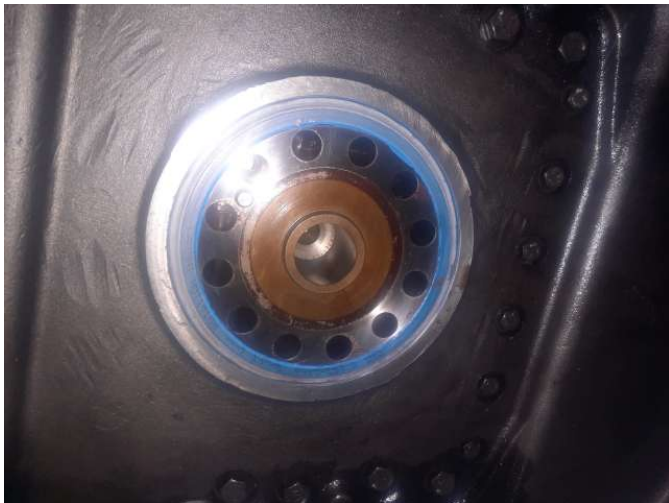
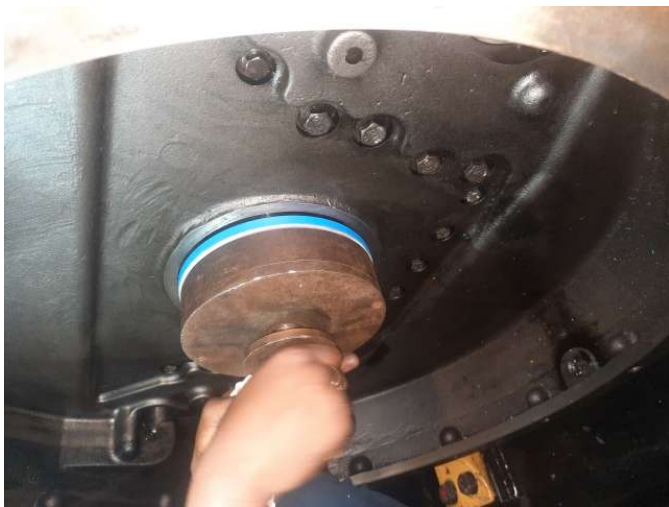
Vessel was enroute to Point e Pitre , Guadeloupe in ballast condition.
 On 30-05-2023/15:15 during the voyage AE N.2 coupling failed and vessel had to be diverted as only AE No.1 Malfunction of AE No.2 caused reduction of power and vessel able to sail by speed about 3-4 knots only. Also Back-up power remaining only by Emergency Generator.

Initial reason for malfunction AE No.2 was damaged rubber coupling on between alternator and engine.
 Damage of rubber coupling caused by leaking luboil on shaft seal and high temprature of air in the Engine Room.
 During repair for replacing rubber coupling observed that alternator shaft is not free spinning.
 AE no.2 Alternator was contaminated inside by oil form leaking shaft seal.
 This caused by overheating of forward bearing of Alternator AE No.2 as it was checked for internal memory parameters by controller connected to PC of MACORP Technician.

Repair done to replace shaft seals and rubber coupling.
 Repair for Alternator AE No.2 arranged in Trinidad upon arrival vessel on 18.06.2023.
