Maritec Tanker Management

Incident Reports Details

Vessel : Bahama Blue	Defect ID : 186	NCR # : 8/2023	Is NCR ? : Yes
----------------------	-----------------	----------------	----------------

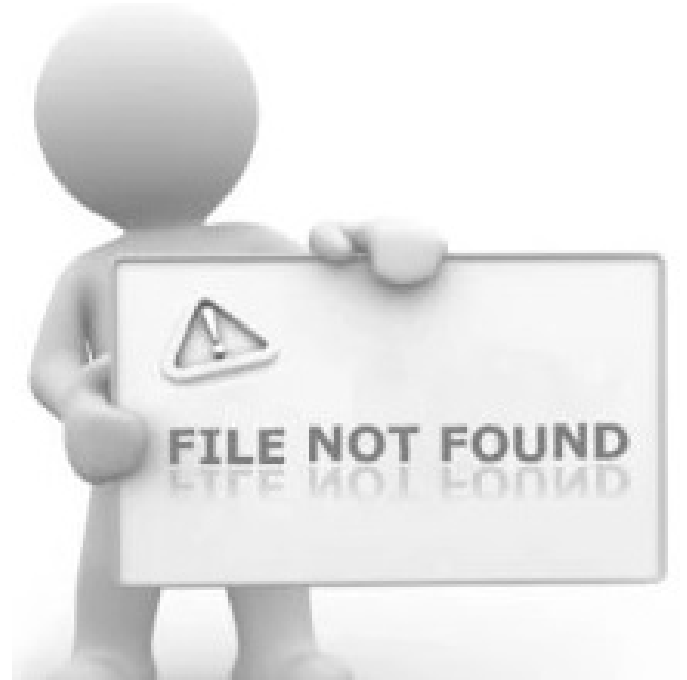
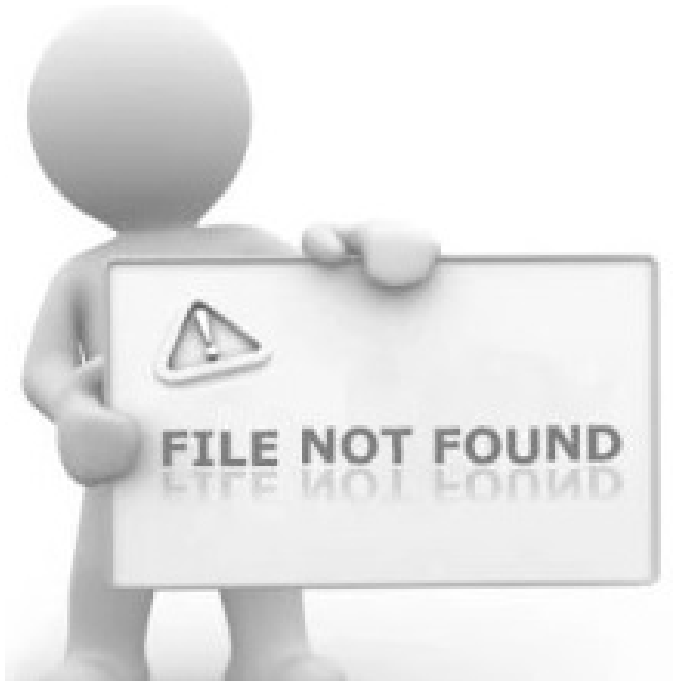
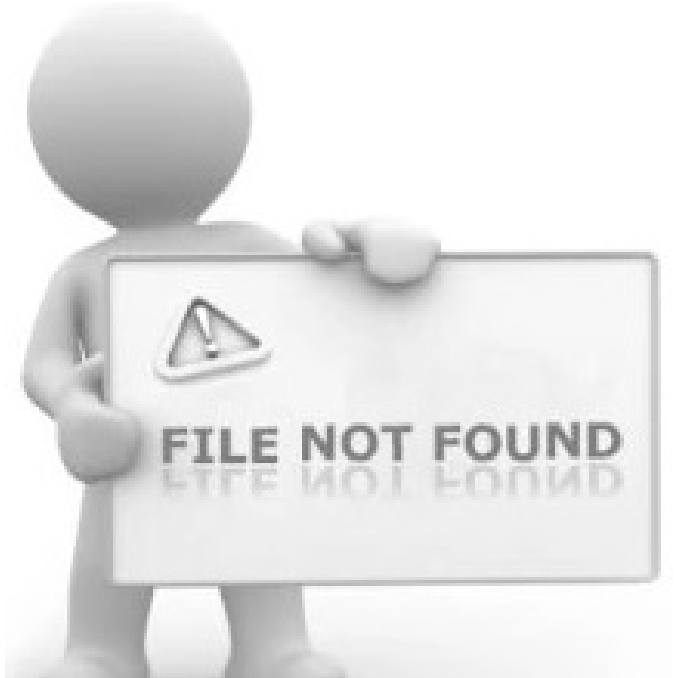
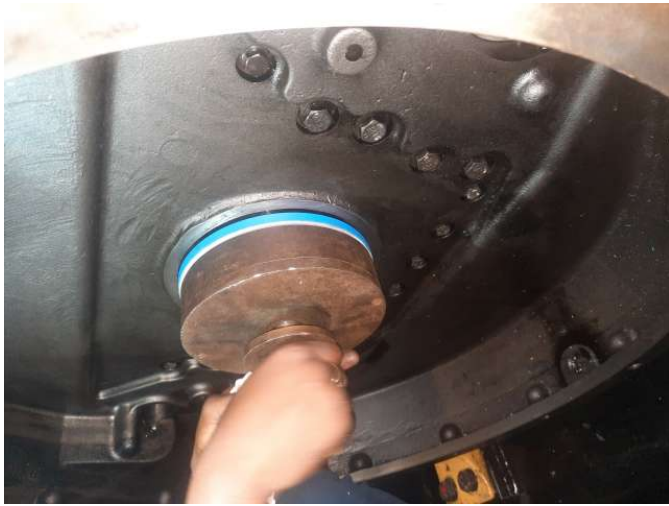
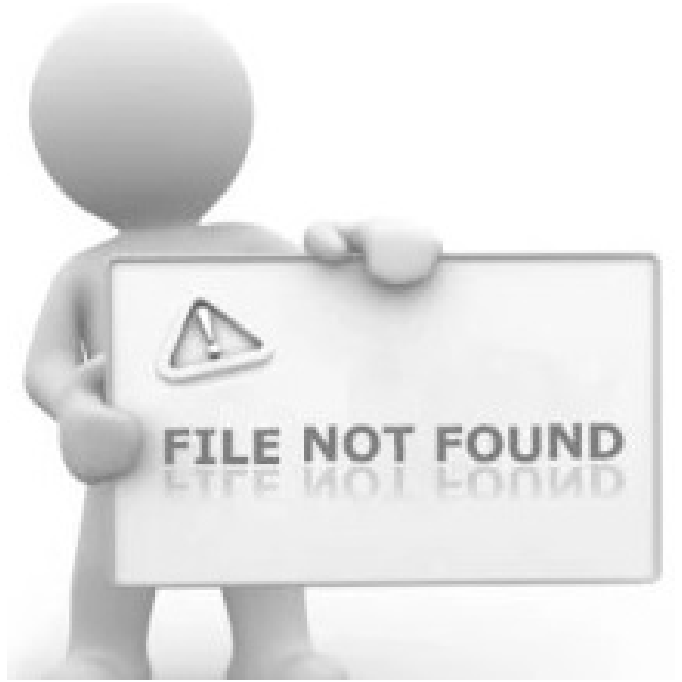
Before & After Pictures	
Before	After

Vessel was enroute to Point e Pitre , Guadeloupe in ballast condition.
 On 30-05-2023/15:15 during the voyage AE N.2 coupling failed and vessel had to be diverted as only AE No.1 Malfunction of AE No.2 caused reduction of power and vessel able to sail by speed about 3-4 knots only. Also Back-up power remaining only by Emergency Generator.

Initial reason for malfunction AE No.2 was damaged rubber coupling on between alternator and engine.
 Damage of rubber coupling caused by leaking luboil on shaft seal and high temprature of air in the Engine Room.
 During repair for replacing rubber coupling observed that alternator shaft is not free spinning.
 AE no.2 Alternator was contaminated inside by oil form leaking shaft seal.
 This caused by overheating of forward bearing of Alternator AE No.2 as it was checked for internal memory parameters by controller connected to PC of MACORP Technician.

Repair done to replace shaft seals and rubber coupling.
 Repair for Alternator AE No.2 arranged in Trinidad upon arrival vessel on 18.06.2023.
