Incident Reports Details

Vessel : Asphalt Teranga	Defect ID : 149	NCR # : 16/2023	Is NCR ? : Yes
--------------------------	-----------------	-----------------	----------------

We have issue with HT Water pressure lost of Main Engine. During investigation we have found the attach pump got failure. Dismantle the pump for inspection and found the pump drive gear shaft worn out and gear got damaged. After open the crankcase inspection door, found water leaking from top of HT pump drive gear. Remove the blank and found very big hole on HT manifold.

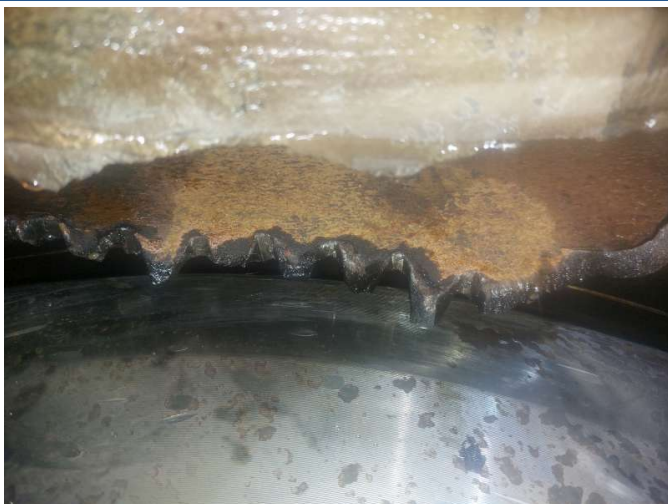
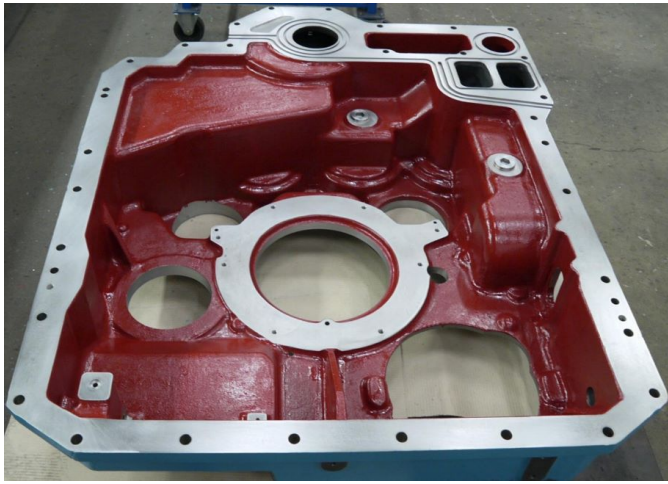
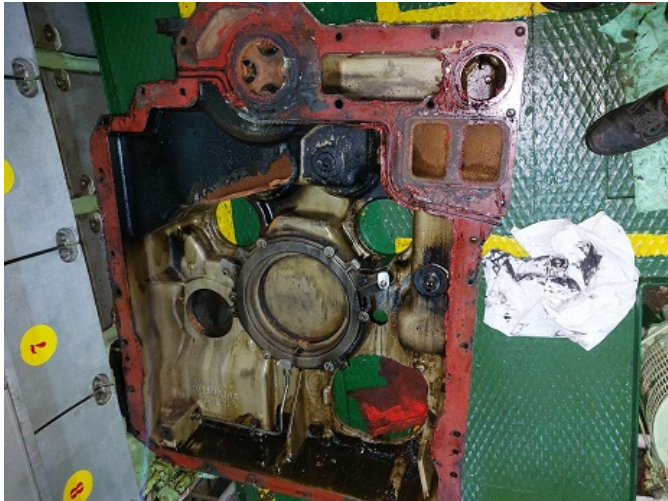
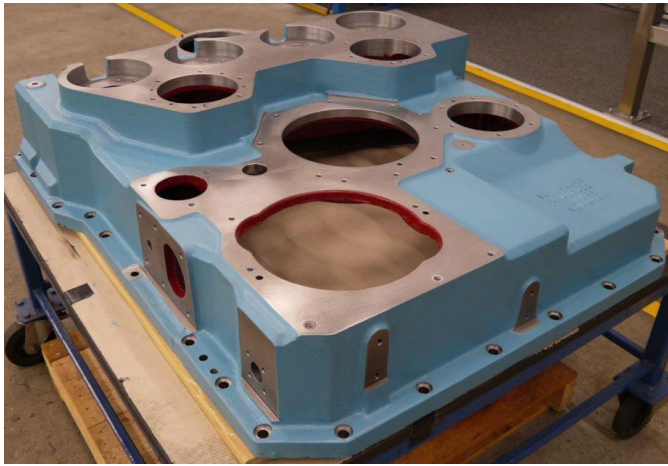
Mechanical Failure - Equipment breakdown - HT pump drive shaft and gear damaged

Planned action:
1.In coordination with office, Commenced preparing Towage operation to the port of Malaga.
2.Continuous monitoring of Set & drift and prepare the vessel for emergency anchoring.
3.To Open up Pump cover for further inspection and to establish the actual cause of damage.
4.Service Technician to be arranged for carrying out required repair.

1.Increasing safety margin for inspection – PMS routines for H/T cooling water system has been reduced from 12000 hours to 9000 hours to ensure required maintenance of cooling water pump has been carried out well before the recommended period of 12000 hours as advised by the manufacturer.
2.Routine maintenance of Cooling water system to be performed regularly under the strict supervision of C/E, Any abnormality identified during the course of inspection must be attended with great care.
3.Incident reports & learnings must be shared with the fleet vessels.
