## **Maritec Tanker Management**

## **Incident Reports Details**

Vessel: Asphalt Teranga Defect ID: NCR #: 16/2023 Is NCR?: Yes

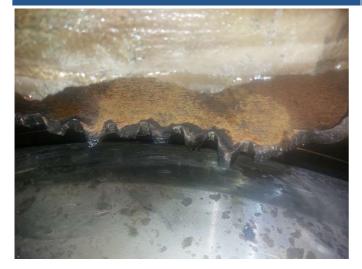
## **Before**

We have issue with HT Water pressure lost of Main Engine. During investigation we have found the attach pump got failure. Dismantle the pump for inspection and found the pump drive gear shaft worn out and gear got damaged. After open the crankcase inspection door, found water leaking from top of HT pump drive gear. Remove the blank and found very big hole on HT manifold.

Mechanical Failure - Equipment breakdown - HT pump drive shaft and gear damaged

- 1.In coordination with office, Commenced preparing Towage operation to the port of Malaga. 2.Continuous monitoring of Set & drift and prepare the vessel for emergency anchoring.
- 3.To Open up Pump cover for further inspection and to establish the actual cause of damage.
- 4. Service Technician to be arranged for carrying out required repair.
