Maritec Tanker Management

Incident Reports Details

Vessel: Asphalt Teranga Defect ID: NCR #: 16/2023 Is NCR?: Yes

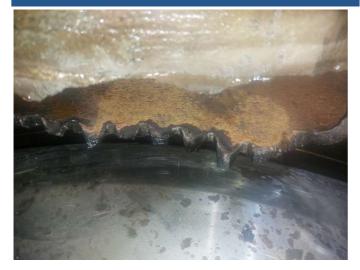
Before

We have issue with HT Water pressure lost of Main Engine. During investigation we have found the attach pump got failure. Dismantle the pump for inspection and found the pump drive gear shaft worn out and gear got damaged. After open the crankcase inspection door, found water leaking from top of HT pump drive gear. Remove the blank and found very big hole on HT manifold.

Mechanical Failure - Equipment breakdown - HT pump drive shaft and gear damaged

- 1.In coordination with office, Commenced preparing Towage operation to the port of Malaga. 2.Continuous monitoring of Set & drift and prepare the vessel for emergency anchoring.
- 3.To Open up Pump cover for further inspection and to establish the actual cause of damage.
- 4. Service Technician to be arranged for carrying out required repair.

- 1.Increasing safety margin for inspection PMS routines for H/T cooling water system has been reduced from 12000 hours to 9000 hours to ensure required maintenance of cooling water pump has been carried out well before the recommended period of 12000 hours as advised by the manufacturer.
- 2. Routine maintenance of Cooling water system to be performed regularly under the strict supervision of C/E, Any abnormality identified during the course of inspection must be attended with great care.
- 3.Incident reports & learnings must be shared with the fleet vessels.

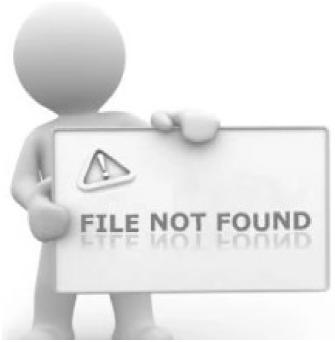
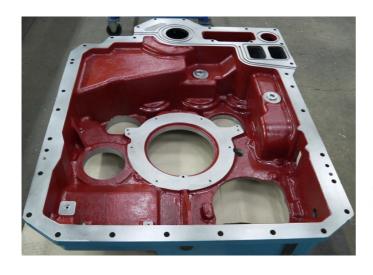
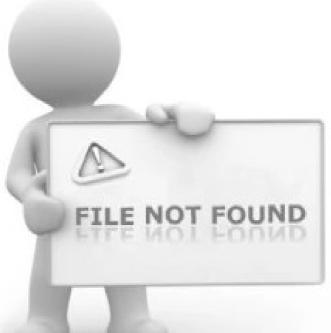
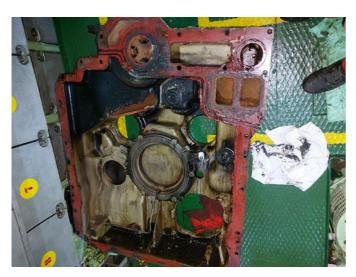
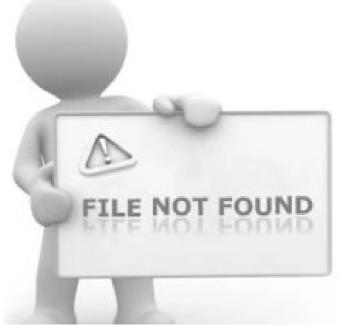
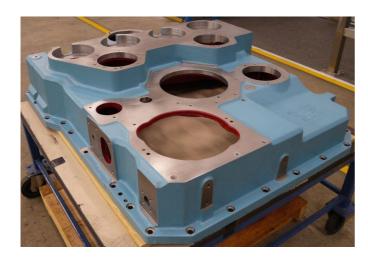
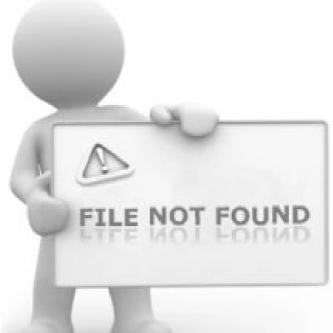
After

On	Ву	Follow Up	
02/Aug/2023	Nawin Khaware	Repairs has been completed on 28th July/ and so finally she sailed out on 28th July/2300 LT. All system found running satisfactorily hence this incident could be considered as closed out now.	
02/Aug/2023	Nawin Khaware	ETC has been changed from "31 Jul 2023" to "03 Aug 2023".
