# Maritec Tanker Management Private Limited

#### **Non Conformance Details**

Vessel: Bahama Blue	Defect ID: 212	NCR # : 2/2024	Is NCR ?: Yes
---------------------	----------------	----------------	---------------

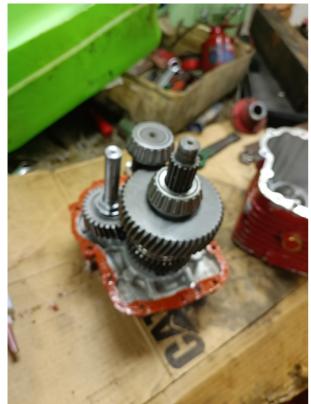
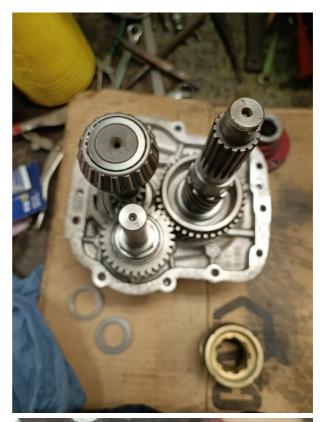
During USCG Inspection, it was noticed that Lifeboat engine was not going on astern movement due issues in engine clutch in system.

General wear & tier of L/B engine clutch in system.

L/B Engine gear box was opened up and observed that ahead gear was stucked with clutch. Same was freed up, system fitted back in place and engine tried out, L/B engine found working satisfactory. Same was reported to Class RINA,USCG and to DPA.

On	Ву	Follow Up	
09/Apr/2024	Petre Aboyan   Staff Code - 10603 - MST	Gear box disembelled, Clutch cone removed, lapping done of wear, general cleaning of gear box done, new oil refilled. Engine tried out in Ahead, Neutral and Astern direction. All in good working order	Link1 Link2
