Maritec Tanker Management Private Limited

Non Conformance Details

Vessel : Bahama Blue Defect ID : 212 NCR # : 2/2024 Is NCR ? : Yes

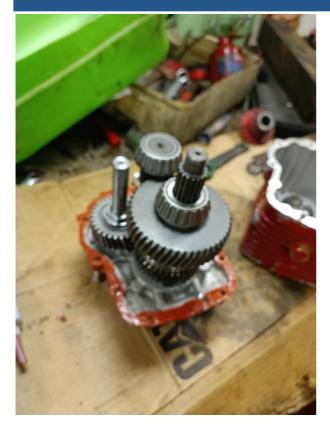
Before

During USCG Inspection, it was noticed that Lifeboat engine was not going on astern movement due issues in engine clutch in system.

L/B Engine gear box was opened up and observed that ahead gear was stucked with clutch. Same was freed up, system fitted back in place and engine tried out, L/B engine found working satisfactory. Same was reported to Class RINA,USCG and to DPA.

Follow Up						
On	Ву	Follow Up				
09/Apr/2024	Petre Aboyan br/> Staff Code - 10603 - MST	Gear box disembelled, Clutch cone removed, lapping done of wear, general cleaning of gear box done, new oil refilled. Engine tried out in Ahead, Neutral and Astern direction. All in good working order	Link1 Link2
