## Maritec Tanker Management

### Non Conformance Details

Vessel : Bahama Blue	Defect ID : 180	NCR # : 3/2023	Is NCR ? : Yes
----------------------	-----------------	----------------	----------------

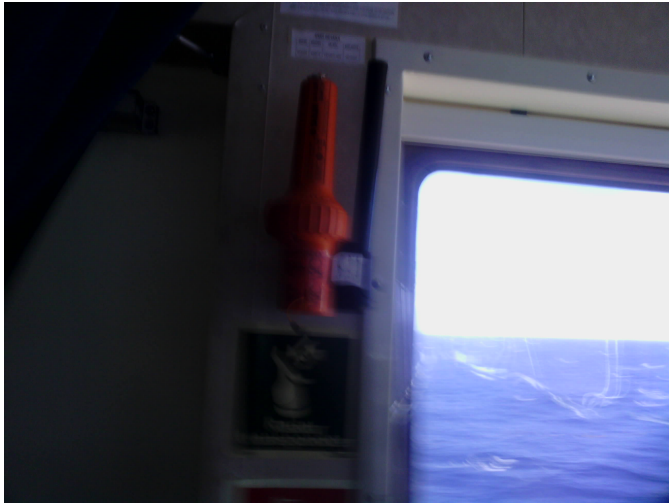
Before

During annual inspection by US Coastguard made deficiency Code 11122(SOLAS 20 III/6.2.2):  
On ships carrying at least two Search&Rescue locating devices and equipped with free fall life boats one of the search and rescue locating devices shall be stowed in the fre fall life boat. There was no search and rescue locating device stored in the free fall life boat.

Company procedure prescribed as per Muster list for 2nd Officer duties to bring SART into the fre fall life boat during emergency/drills.
