# Maritec Tanker Management Private Limited

## Non Conformance Details

Vessel : Bitu Express	Defect ID : 339	NCR # : 4/2024	Is NCR ? : Yes
-----------------------	-----------------	----------------	----------------

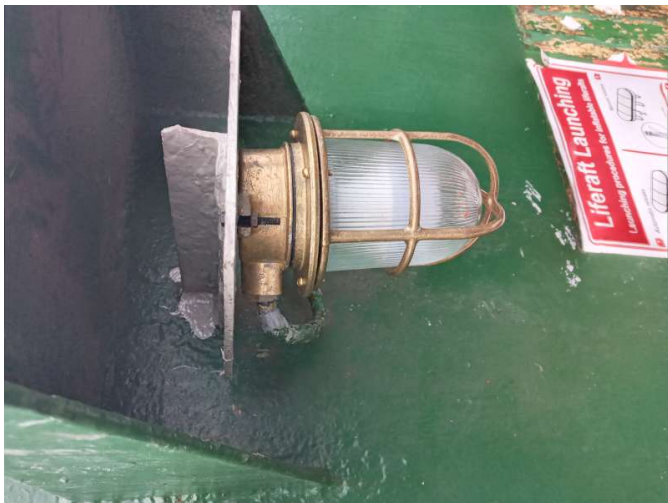
Before

The condition of the ship & it's equipments shall be maintained to conform to the provisions of present regulations to ensure ships in all respect proceed to sea without any danger to ship or it's persons onboard. PSCO observed emergency light above forward liferaft had been broken off dedicated bracket and being held on with nylon rope. Vessel must install the fixed bracket at the first ballast voyage after completion of discharge at US ports.

Lack of routine maintenance for LSA/FFA items, General wear & tier due ageing.

Vessel will plan to undertake the jobs during ballast voyage.

On	By	Follow Up	
05/Apr/2024	Marin Panait   Staff Code - 10017 - MST	Vessel in ballast cond from 03-04-2024, Office informed, HWP in place for this date, welded accordingly new support, replace the lights with new one.	<a href="#">Link1</a> <a href="#">Link2</a> <a href="#">Link3</a> <a href="#">Link4</a>
31/Mar/2024	Marin Panait   Staff Code - 10017 - MST	Identified during PSC inspection, vessel check the possibility to solve. As the vessel ins in loaded condition, and for rectified this observation need HW permit, vessel request to postpone the job till ballast passage ( aprox 3rd April 2024 ), when the vessel can obtain HW permit. Checked on board, vessel have materials to fabricate new support and also have new spare emergency light.	<a href="#">Link1</a> <a href="#">Link2</a> <a href="#">Link3</a> <a href="#">Link4</a> <a href="#">Link5</a> <a href="#">Link6</a> <a href="#">Link7</a> <a href="#">Link8</a>
