# Maritec Tanker Management Private Limited

## Near Miss Details

Vessel : Bitu River

Defect ID : 33

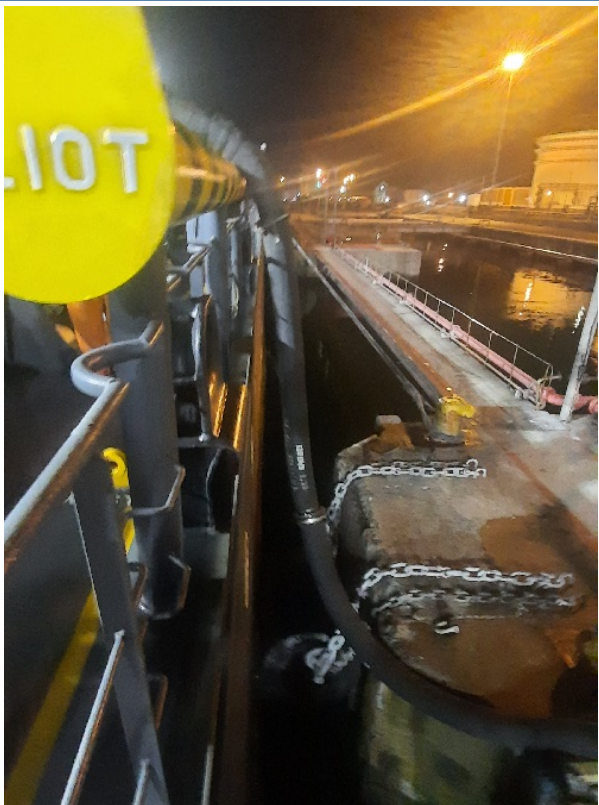
While carrying out cargo hose air blow during cargo operations at Cape Town the cargo hose outer rubber layer got ruptured. The inner steel cargo hose was intact. Had the steel hose been of relatively poor quality like the outer rubber layer the steel hose could have also ruptured resulting in oil spill.

The outer rubber layer of cargo hose observed to be of relatively poor quality.

Follow Up			
On	By	Follow Up	
05/Oct/2023	Nawin Khaware	Matter has been taken up with the Manufacturer. As of now, it was evident that shore did not follow the correct procedure for air blow to cargo hoses after completion of discharge ops which lead to sudden pressure surge in the line & casing damage to the outer layer of hoses. In consultation with Chartering Team, Shore was advised to stop the air blow and going forward vessel will be carrying out air blow to the cargo lines after discharge ops.

Feed back about the cargo hose outer rubber layer to be given to Office. Disconnect cargo hoses and replaced with another spare.
