Maritec Tanker Management Private Limited

Near Miss Details

Vessel : Bitu River

Defect ID : 34

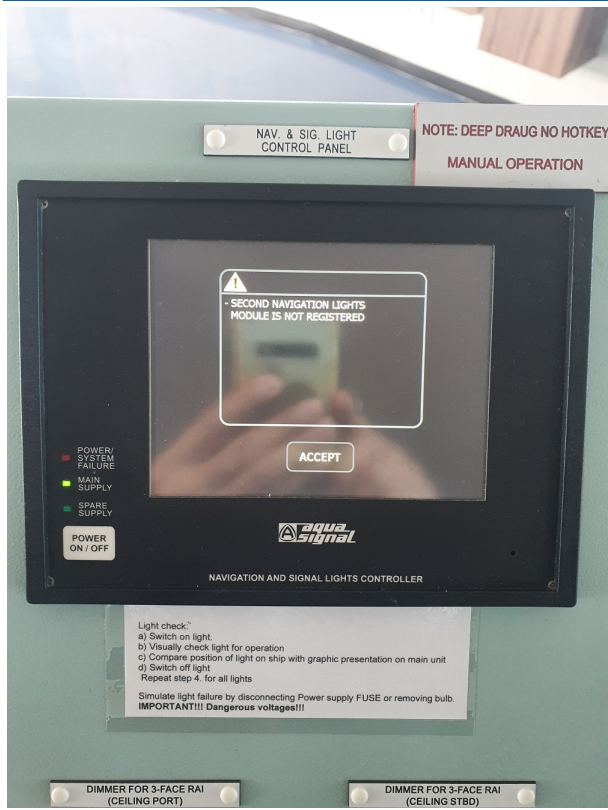
Manual for Navigation and signaling light panel equipment is not matching with onboard existing equipment. Already equipment is defective and GC 079 raised. However, it is quite difficult to operate navigation light, in case light is busted or not working then no any alarm or indication to notify the watch keeper. OOW always check visually by themselves during change of watch and frequently during watch to confirm that navigational light is working.

On the navigational light controller when selecting RAM and NUC light controller is working. Only when selecting navigation and anchor lights this alarm is showing in the light controller/panel (2nd navigational module is not registered.)

At port, the navigational light continue on and need to switch off the main power to keep it off.

Manual for Navigation and signaling light panel equipment is not matching with onboard existing equipment onboard.

GC send to the maker / While waiting for the GC response / action, OOW routinely check visually the navigational light during navigation.

Navigational light controller must be replaced or rectified.

On	By	Follow Up	
24/Nov/2023	Marin Ceapa Staff Code - 10446 - MST	After replacement of INTNL-10 with new ITNL-3 system is working fine.	Link1
06/Oct/2023	Marin Ceapa Staff Code - 10446 - MST	The new spares received and replaced with old display unit. The System was tested and the same repeat fault was observed "SECOND NAVIGATION LIGHTS MODULE IS NOT REGISTERED". The GC079 defects is still existing after replacement of the new spare display unit with an additional new defect coming up by which the Navigation lights cannot be switched ON.	Link1
05/Oct/2023	Nawin Khaware	Please advise the updated status.
