Maritec Tanker Management

Near Miss Details

Vessel : Bahama Blue

Defect ID : 139

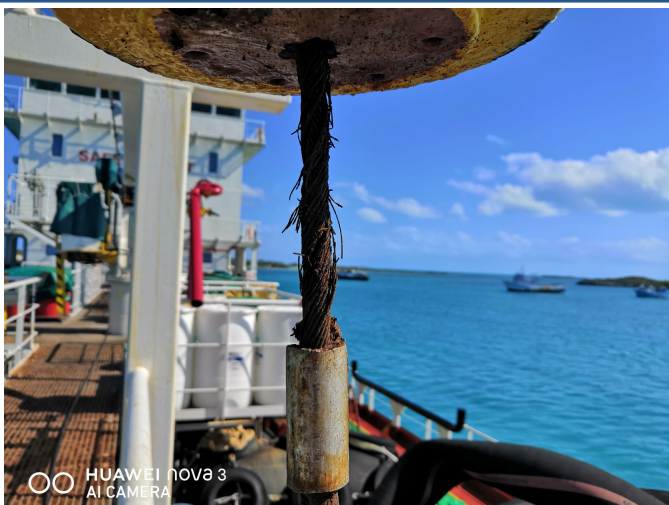
Before

During monthly routine check / inspection / greasing of deck cargo hose crane found that the crane wire part in between the crane hook and the block / weight not in good condition and observed to be corroded. The block / weight believed to be too heavy for the size of the wire as it gave too much tension to affected part when lifting up load. Also the crane hook part that make it rotate freely painted and not rotating at all.

Corroded wire part.

Replaced with new spare wire. Maintenance carried out to the hook.

Proper Maintenance and lubrication and follow maintenance schedules.
To maintain with oil or grease the hook part that make it rotate freely.
Avoid painting the hook part make it rotate freely.
