Maritec Tanker Management Private Limited

Near Miss Details

Vessel : Bitu River

Defect ID : 57

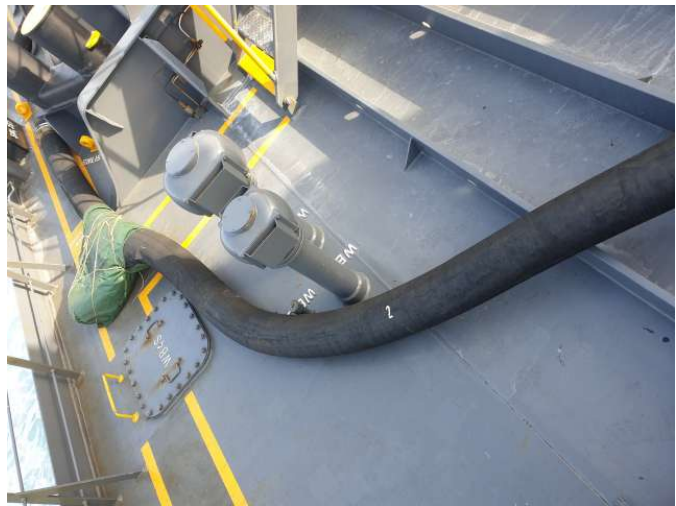
During air blow of shore line by terminal staff, shore valve wasn't closed and a sudden raise of pressure surge on ship's cargo hose which damaged the hose outer rubber protection .Inner steel cargo hose remain intact ,otherwise a cargo spill was inevitable.

Improper communication between ship's staff and terminal staff.
Cargo hose poor quality.The test certificate for the hose state that hose was tested at 24 bars

Instructed shore staff to close the shore valve ,and restart the shore line air blow

Ch.officer to be sure that air blow procedure are proper stated/discussed during key meeting,cargo operation agreement.
