# Maritec Tanker Management

## Near Miss Details

Vessel : Bitu River	Defect ID : 28
---------------------	----------------

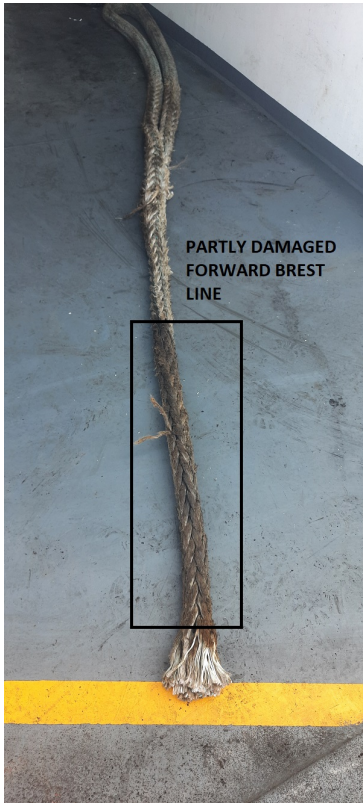
Mooring ropes of inboard head lines and stern lines found slightly chafed. Further chafing could cause the mooring ropes to deteriorate and render not purposeful during mooring stations and possible rope failure/ damage/ injury in subsequent operations if not attended.

PARTLY DAMAGED  
FORWARD BREST  
LINE

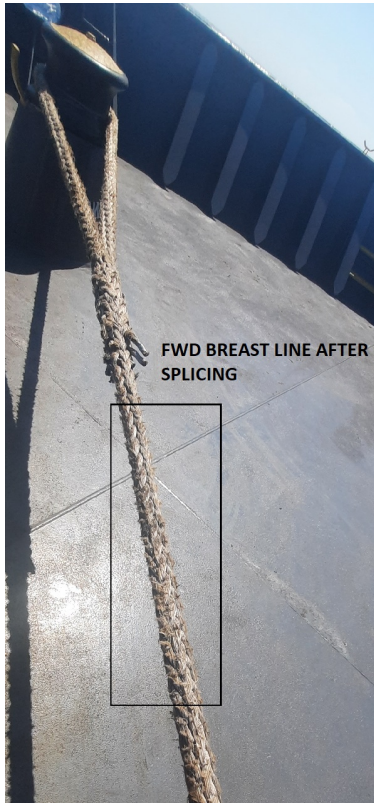
FWD BREAST LINE AFTER  
SPLICING

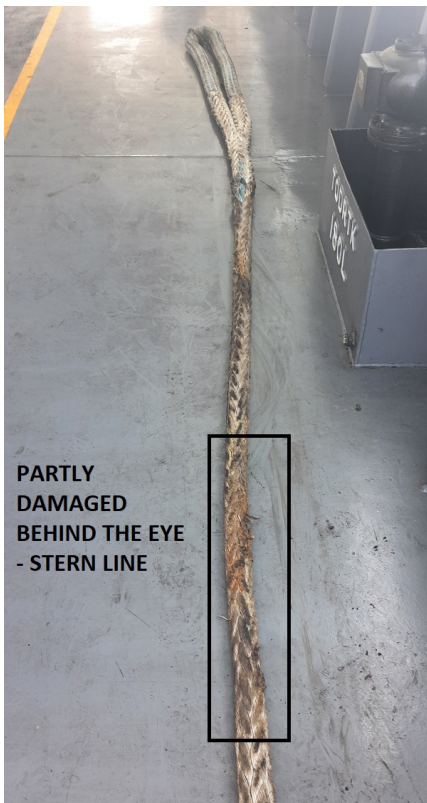
PARTLY  
DAMAGED  
BEHIND THE EYE  
- STERN LINE

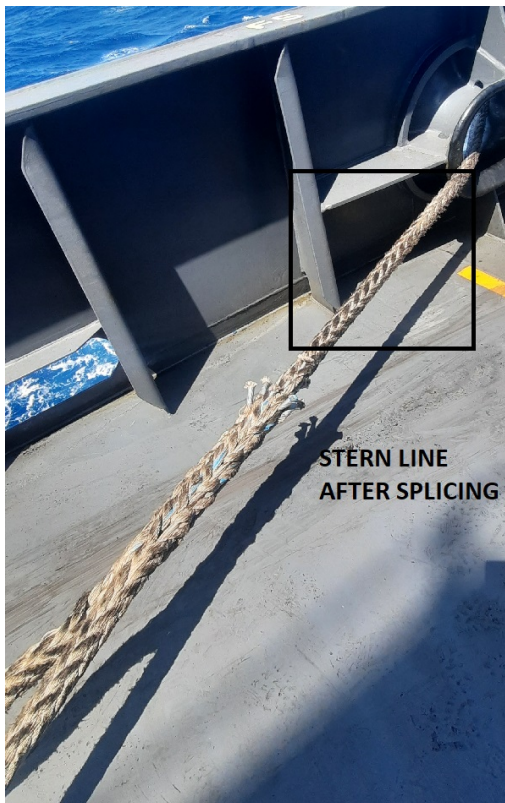
STERN LINE  
AFTER SPLICING
