## Maritec Tanker Management

### Near Miss Details

Vessel : Bitu Express

Defect ID : 181

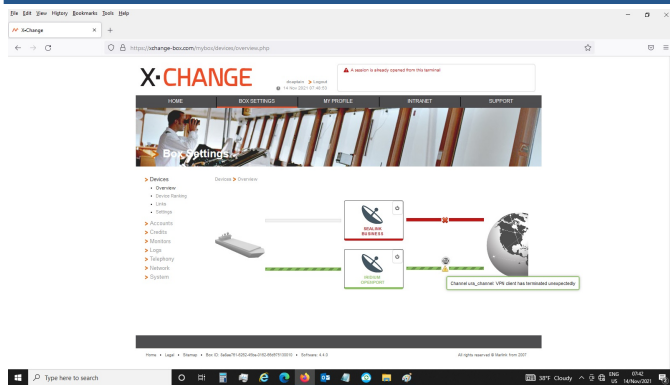
**Before**

During HRA transit , VSAT vessel communication system running in very poor quality.

Seeting Of the VSAT antenna for better coverage on vessel trading area
