Maritec Tanker Management

Near Miss Details

Vessel : Biskra

Defect ID : 81

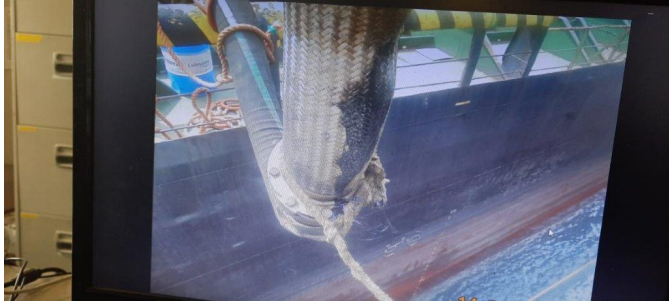
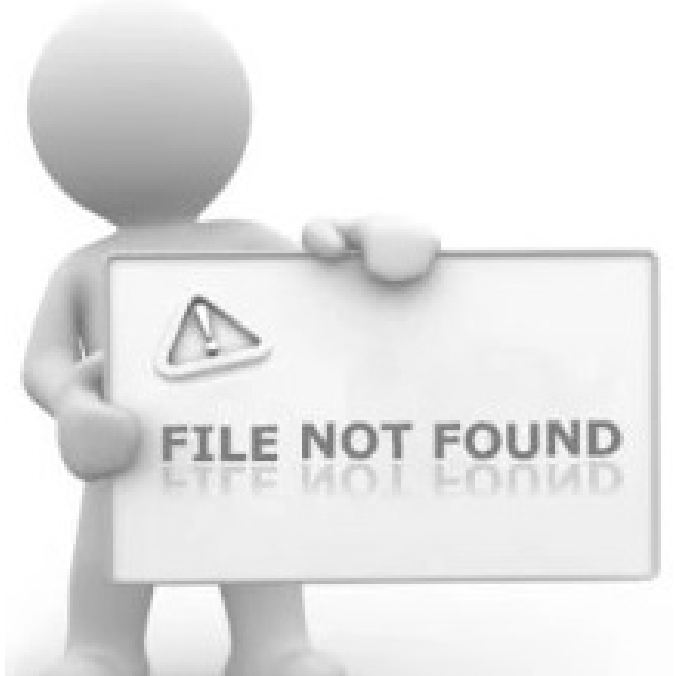
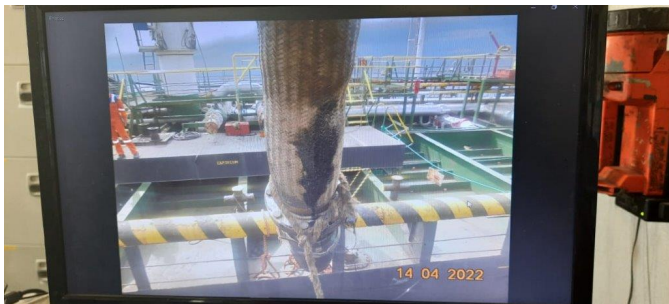
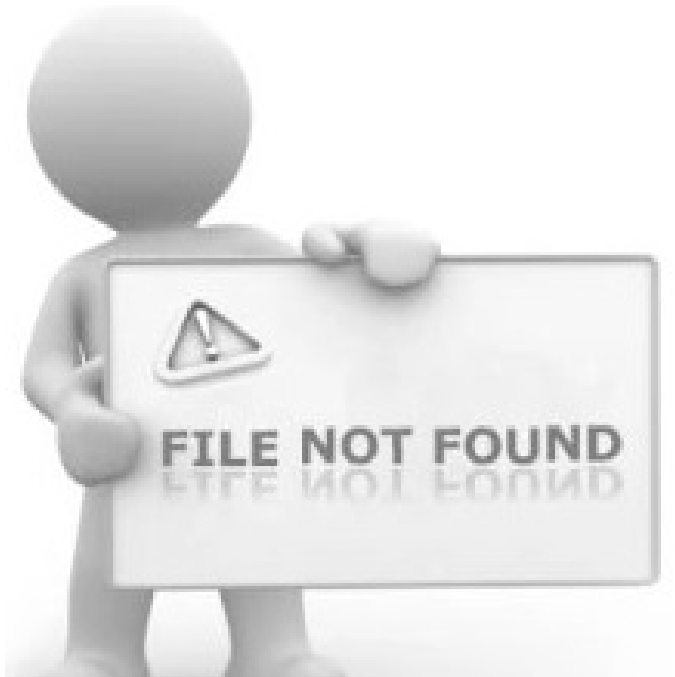
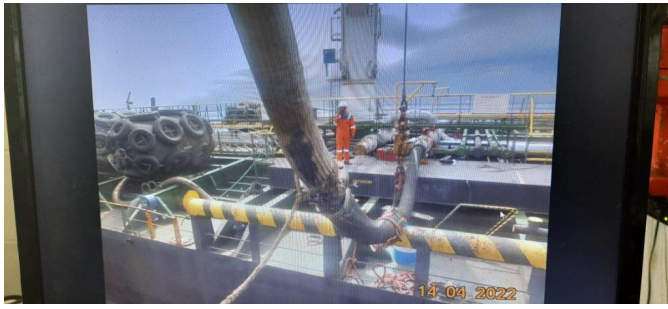
Before & After Pictures

During Loading operation (STS) from BITU ATLANTIC, minor leak found on vessels hose. At the time of Leak the Manifold pressure was zero on Biskra and 1 bar on Bitu Atlantic.

Wear and Tear

Excessive Wear and Tear

Stopped Loading immediately and Disconnected the hose. Change the hose and Resumed Loading.

Hoses to be pressure tested regularly and During connection laying should be proper.

26/Apr/2022	Ayaz Eqbal Upadhye Staff Code - 10346 - MST	The damaged hose is not in use anymore.	
-------------	--	---	--
