# Maritec Tanker Management

## Near Miss Details

Vessel : Biskra

Defect ID : 81

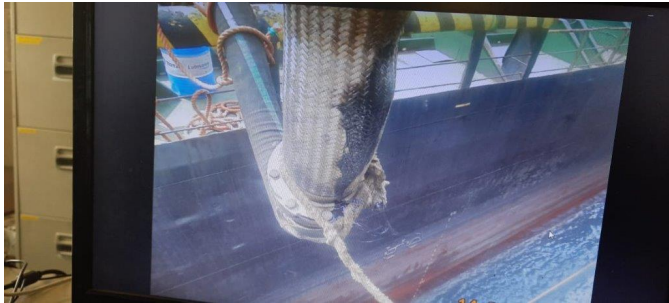
**Before & After Pictures**

During Loading operation ( STS) from BITU ATLANTIC, minor leak found on vessels hose. At the time of Leak the Manifold pressure was zero on Biskra and 1 bar on Bitu Atlantic.

Wear and Tear

Excessive Wear and Tear

Stopped Loading immediately and Disconnected the hose. Change the hose and Resumed Loading.

Hoses to be pressure tested regularly and During connection laying should be proper.

26/Apr/2022	Ayaz Eqbal Upadhye   Staff Code - 10346 - MST	The damaged hose is not in use anymore.	
-------------	--	---	--
