Maritec Tanker Management

Near Miss Details

Vessel : Bitu Atlantic

Defect ID : 192

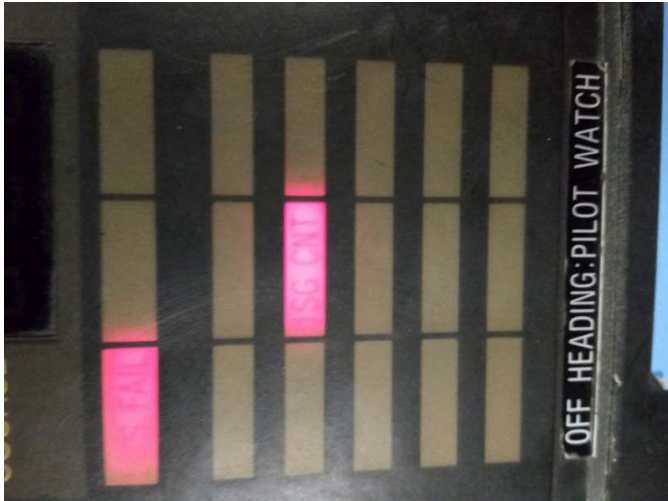
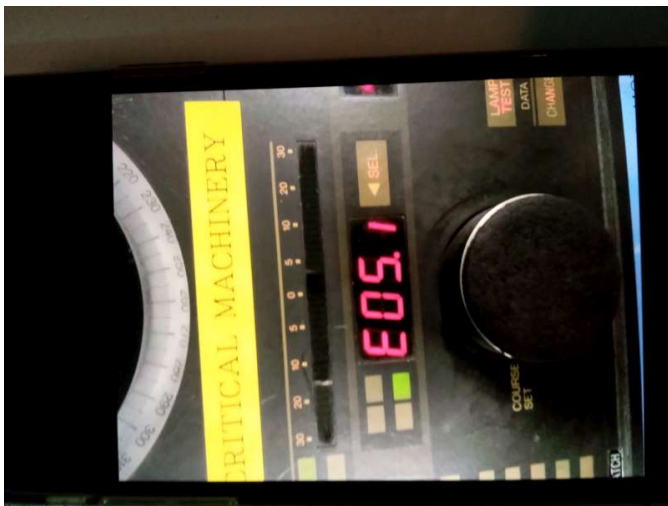
Malfunctioning of bridge steering system with number 1 steering motor.
When number 1 steering motor selected for steering ,rudder does not follow desired helm order & gives system failure alarm on console (alarm code E5.1:servo loop fail).
Although we tried out steering from steering flat ,working normal.

Malfunctioning of electrical communication between bridge steering console and steering gear motor no1.
Local Hand steering on emergency mode at steering gear room under steering gear motor no1 tested and working good.

ETO checked system for any damage of electrical part. Cause unknown.
On this moment vessel steering is engaged on steering gear motor no2 which is designated for emergency.
Running well.

Proper test and inspection a/p jod duty.
