Maritec Tanker Management

Near Miss Details

Vessel : Bitu River

Defect ID : 31

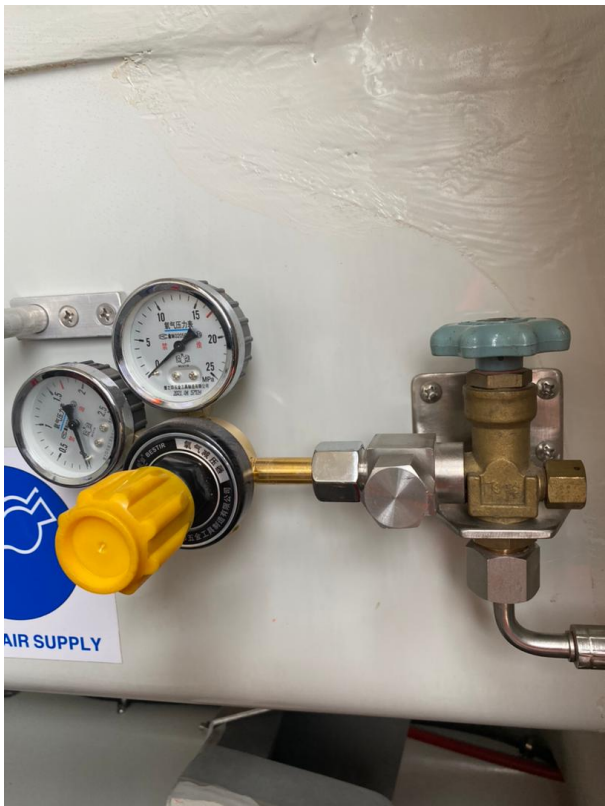
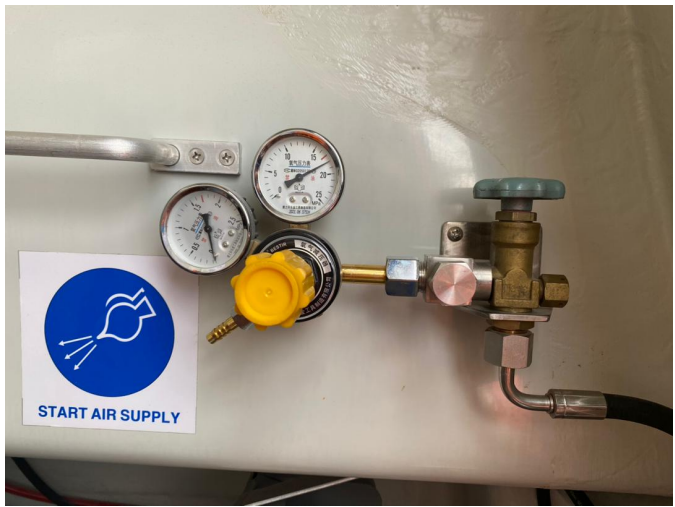
During routine checks, leakage was found in the hose coupling of the lifeboat air support system.

Improper tightness of coupling.
