# Maritec Tanker Management

## Near Miss Details

Vessel : Bitu River

Defect ID : 31

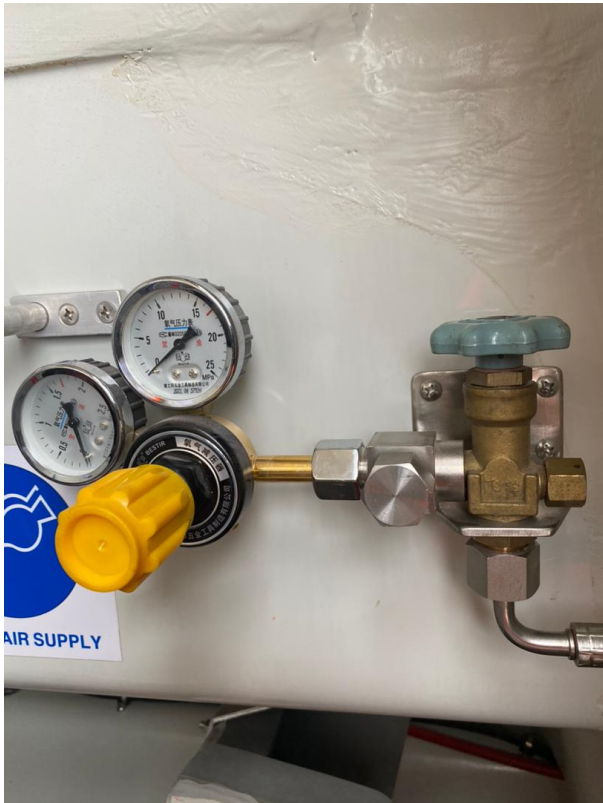
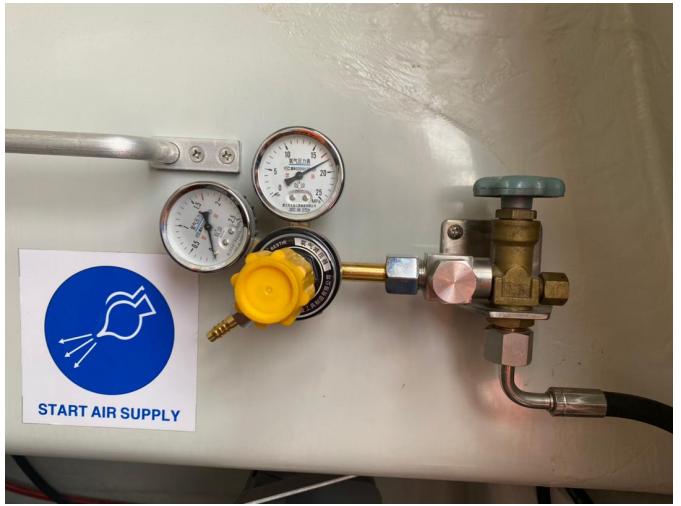
During routine checks, leakage was found in the hose coupling of the lifeboat air support system.

Improper tightness of coupling.
