Maritec Tanker Management Private Limited

Near Miss Details

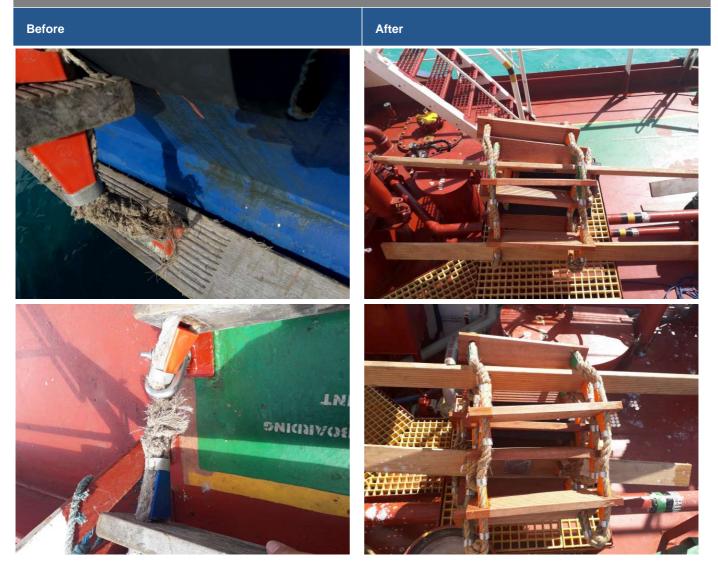
Before & After Pictures

Follow Up							
On	Ву	Follow Up					
22/Nov/2023	Vitaliy Klimenko Staff Code - 10633 - MST	causes: Due to prolong exposure to sun and sea water pilot ladder rope and condition become bad. Corrective action: Life ring with line stand-by at the pilot boarding area, requesition raise for pilot ladder. Preventive Action: After use of pilot ladder secure in the shelter area and cover with canvas to prevent direct or prolong exposure in the sunight and sea water.
