# Maritec Tanker Management

## Near Miss Details

Vessel : Bitu Express

Defect ID : 125

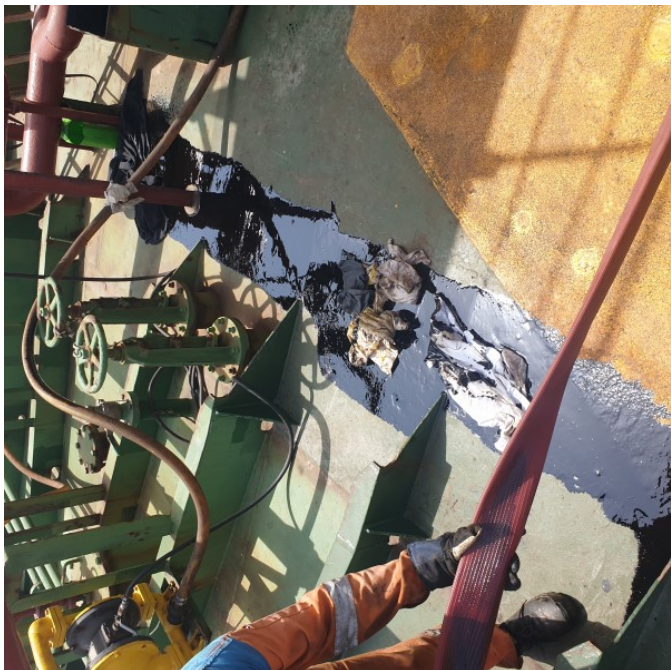
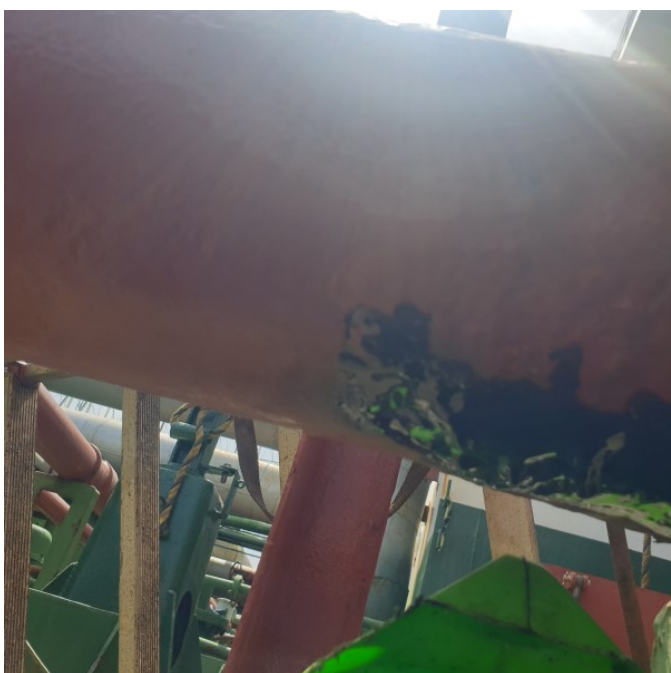
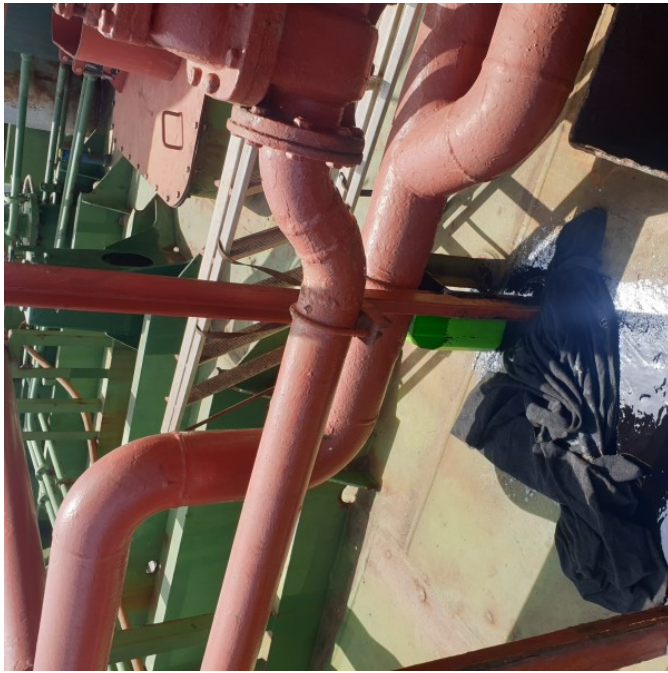
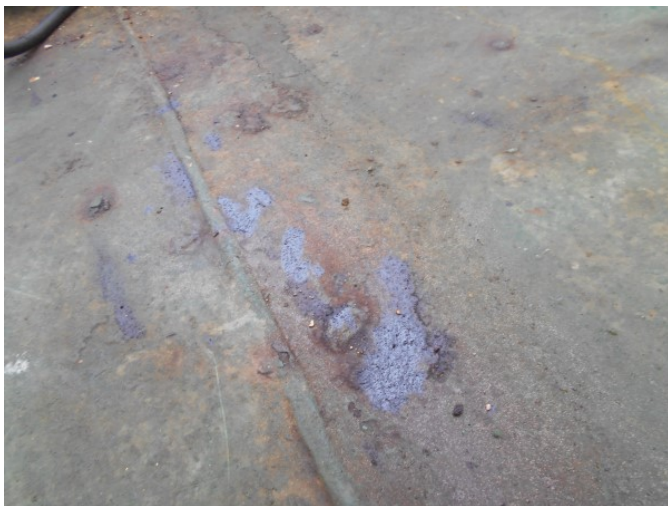
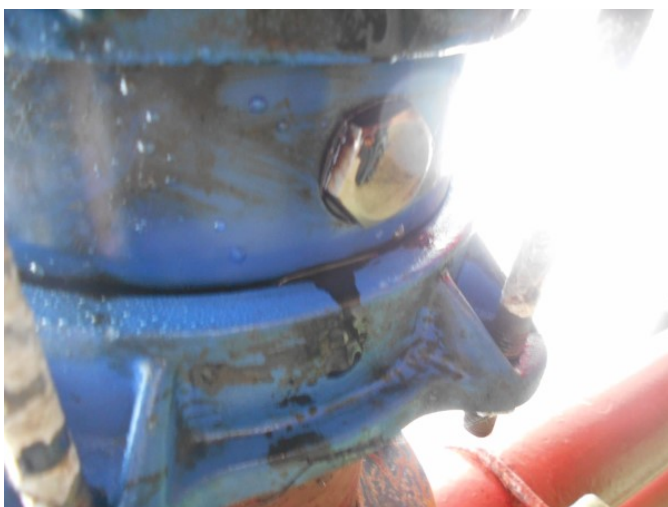
Oil spill on deck portside front of accommodation due to bunker line pipe leakage.

Lack of maintenance and poor condition of bunker pipe material

All crew were alerted, immediately oil spill reponse, commenced cleaning the affected area.

Bunker line to be tested before each use.  
That part of deck bunker pipe should be renewed. Company was informed.

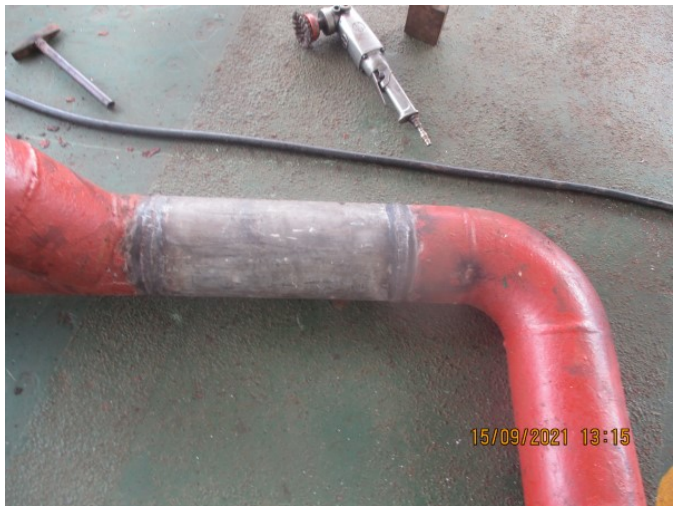
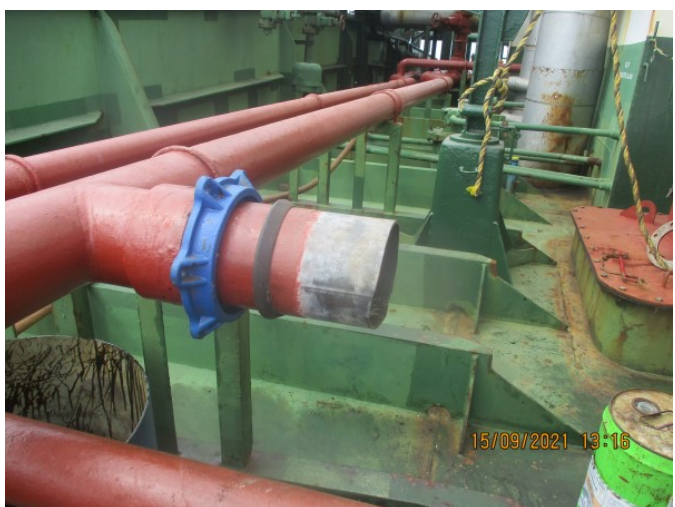
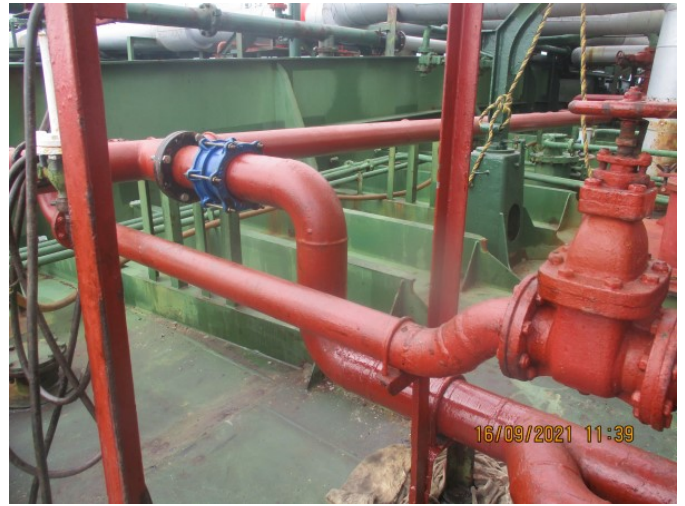
On	By	Follow Up	
29/Sep/2021	Gelu Antin   Staff Code - 10124   - MST	The Bunker pipe temporary repaired using a ballast coupling still has leaks	<a href="#">Link1</a>
22/Sep/2021	Gelu Antin   Staff Code - 10124   - MST	Bunker pipe was temporary repaired by ship staff. Bunker line was tested after temporary repairs by ship staff.	<a href="#">Link1</a> <a href="#">Link2</a>
