Maritec Tanker Management

Near Miss Details

Vessel : Bitu Express

Defect ID : 125

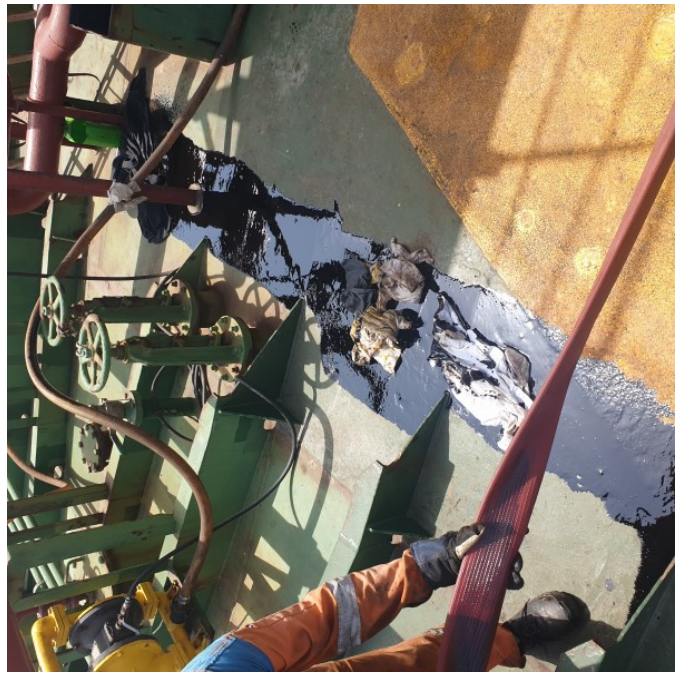
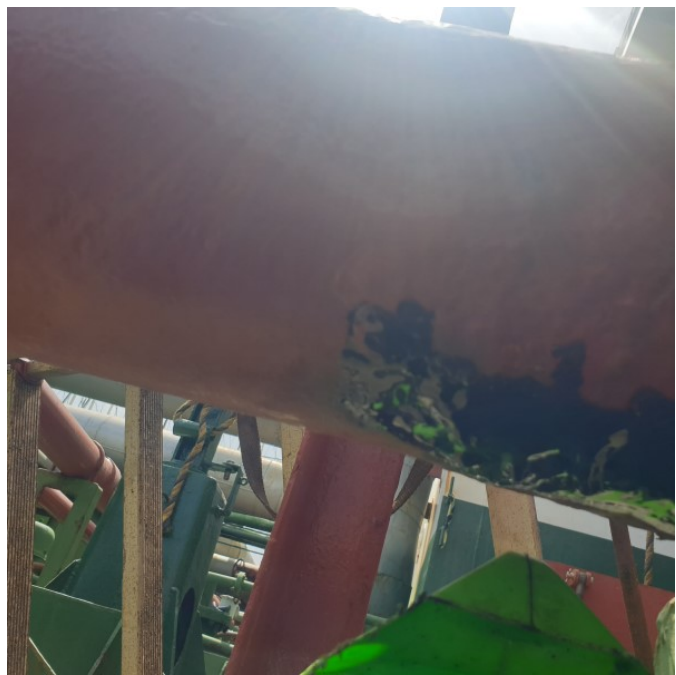
Oil spill on deck portside front of accommodation due to bunker line pipe leakage.

Lack of maintenance and poor condition of bunker pipe material

All crew were alerted, immediately oil spill reponse, commenced cleaning the affected area.

Bunker line to be tested before each use.
That part of deck bunker pipe should be renewed. Company was informed.

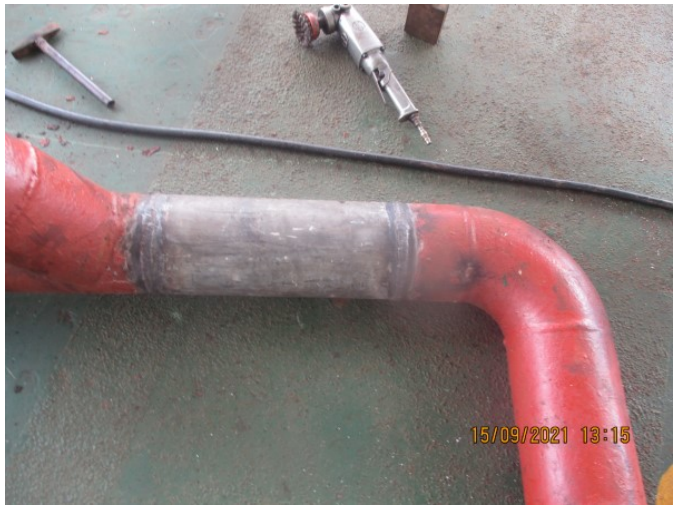
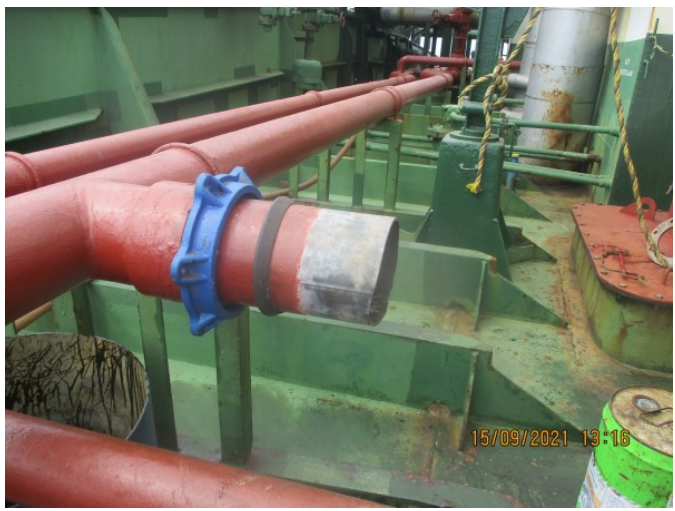
On	By	Follow Up	
22/Sep/2021	Gelu Antin Staff Code - 10124 - MST	Bunker pipe was temporary repaired by ship staff. Bunker line was tested after temporary repairs by ship staff.	Link1 Link2
