Maritec Tanker Management

Near Miss Details

Vessel : Bitu Express

Defect ID : 125

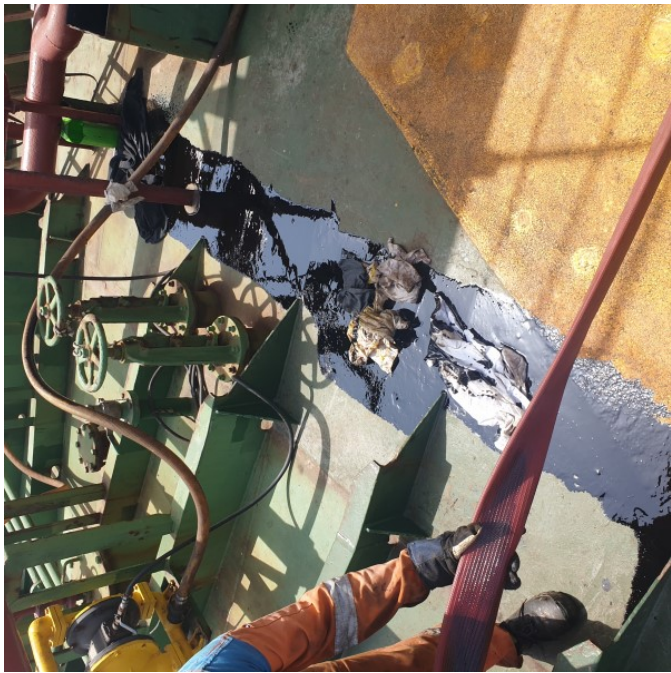
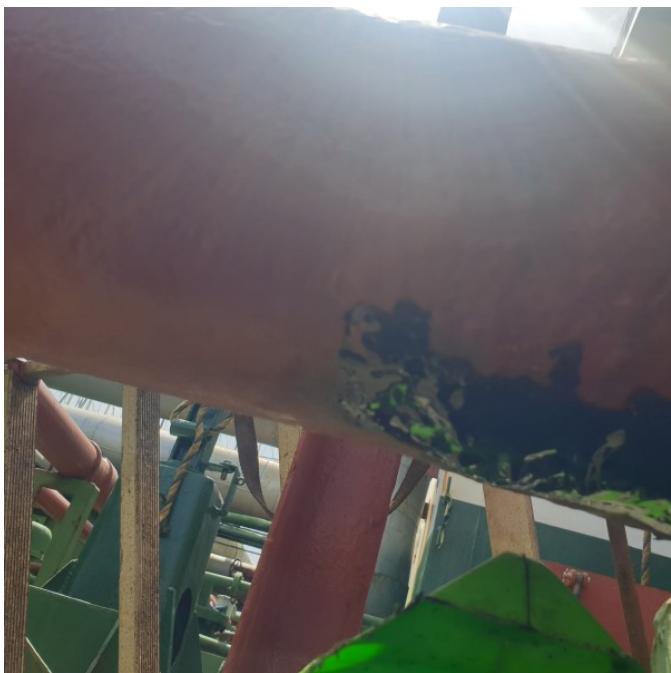
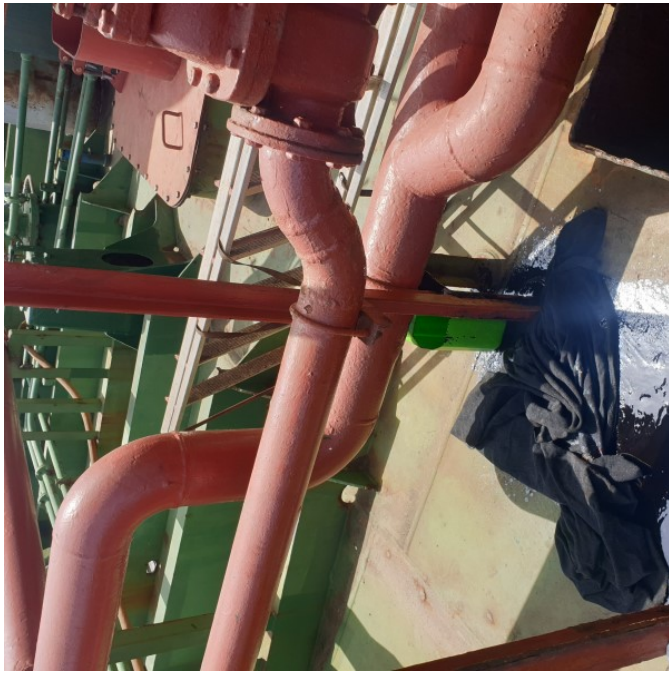
Oil spill on deck portside front of accommodation due to bunker line pipe leakage.

Lack of maintenance and poor condition of bunker pipe material

All crew were alerted, immediately oil spill reponse, commenced cleaning the affected area.

Bunker line to be tested before each use.
That part of deck bunker pipe should be renewed. Company was informed.

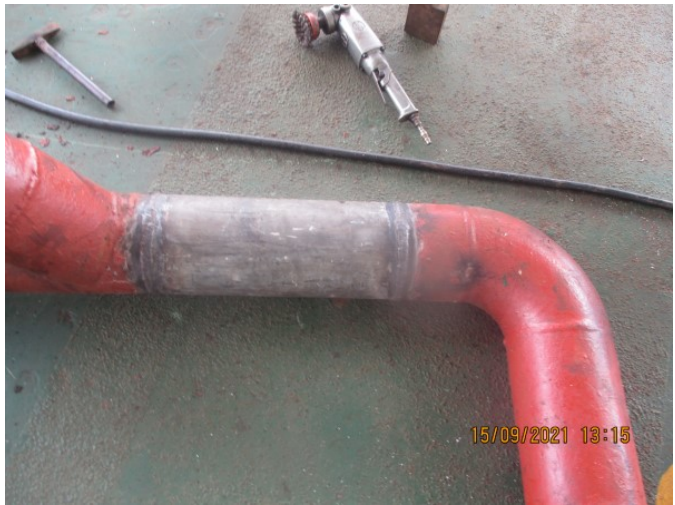
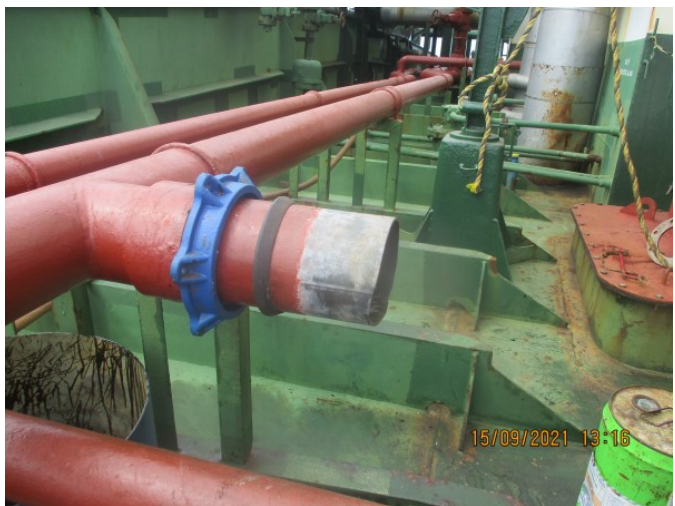
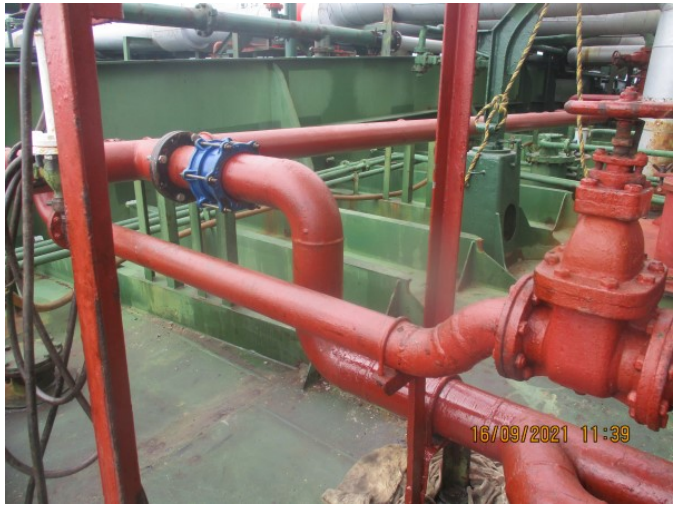
On	By	Follow Up	
22/Sep/2021	Gelu Antin Staff Code - 10124 - MST	Bunker pipe was temporary repaired by ship staff. Bunker line was tested after temporary repairs by ship staff.	Link1 Link2
