Maritec Tanker Management Private Limited

Near Miss Details

Vessel : Bitu River

Emergency fire pump suction filter chocked

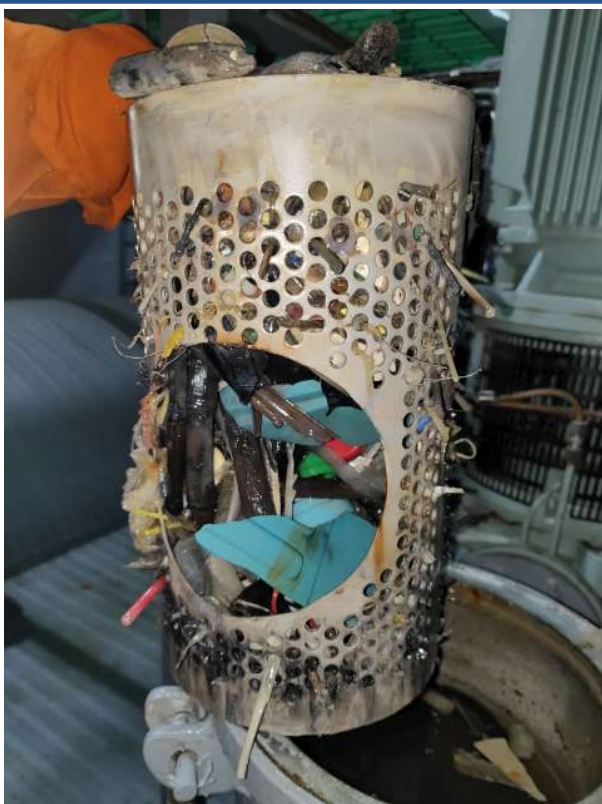
Before

During weekly routine the emergency fire pump automatically stopped in trip mode. After investigation we found the sea water suction filter badly fouled with plastic material

Root cause: West African waters are very dirty and polluted especially with plastic materials, often chocking the sea water suction filters
