Maritec Tanker Management

Near Miss Details

Vessel : Bitu River

Defect ID : 29

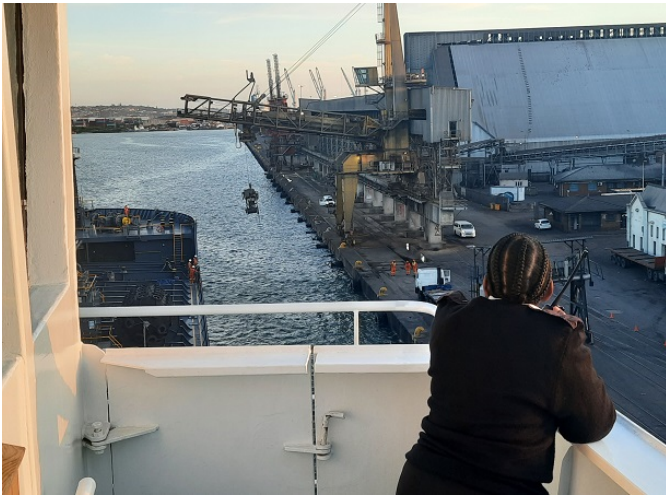
Before

During berthing at Durban port, Maydon #- 7. When vessel planned the final approach to berth. Officer assigned to forward station reported that the container terminal crane boom distance from the bow was decreasing and might not have enough space for the vessel to come alongside. Bridge team informed the pilot and pilot instructed the terminal to raised the boom. Vessel approached the berth slowly until alongside and well secured to the berth.

Terminal designed not solely for tanker vessel but also for general cargo vessels. Terminal did not keep additional safe margin distance to keep the hanging obstruction well clear for our vessel for berthing.

Proper coordination with pilot and terminal. Good communication with all

Pre -arrival information exchange between vessel and port. Always approach the berth with safe speed taken into consideration any obstruction on the berth. Good communication / reporting system with all mooring stations to the bridge.
