Maritec Tanker Management Private Limited

Near Miss Details

Vessel : Bahama Blue

Defect ID : 185

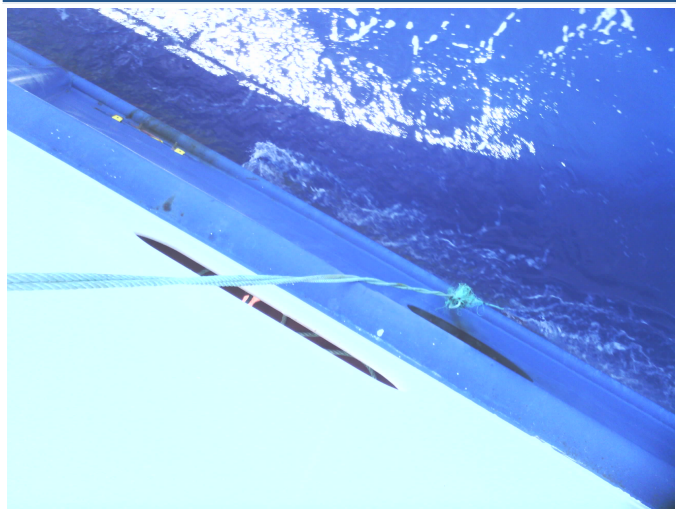
This is to report you that we found rope probably belong to fishing net which was observed floated on starboard side close to front of accommodation.
Crew picked up the loose end of rope and tried to remove it but seems rope secured at bottom side by bottom anodes.
Presently rope secured to deck. Planning to remove it by using work boat in next convenient port. Diameter of rope about 10 mm, loose end length about 5 meters.
The distance from rope end to aft thrusters was about 10 m when loose rope was floating on water surface.

Vessel has fishing ropes stuck on the bottom anodes while sailing across coastal water full of fishing nets.

One loose end of this fishing rope was connected with ship's messenger rope and secured on deck.
At anchorage crew was using work boat pulling loose end of fishing rope with connected messenger into forward of vessel and put on mooring winch.
Fishing rope was finally removed from bottom anode where it was stuck.

Keep proper look-out to avoid area with fishing nets.
Use search lights for obtaining look-ahead safety area clear of fishing nets.
