Near Miss Details

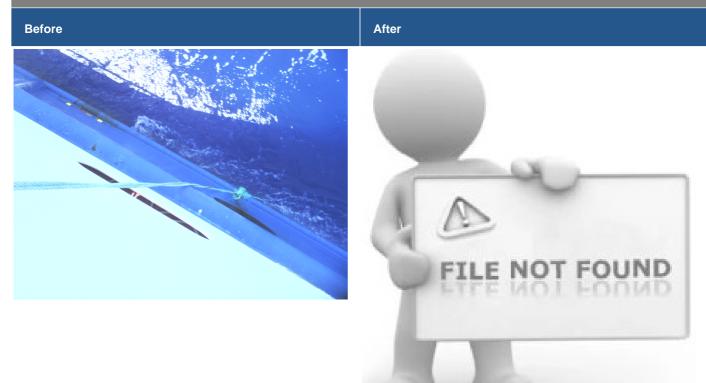
Before & After Pictures

Guidance: 01) Please do not mention any names in the near miss report. 02) The confidentiality will be maintained by removing the name of the vessel when the report is circulated to the different vessels in the fleet. 03) NOTE: ADDITIONAL INFORMATION IF REQUIRED TO BE ADDED IN A SEPARATE SHEET AND ATTACHED TO THIS REPORT.									
Vessel : Bahama Blue				Defect ID: 185					
Defect Details									
This is to report you that we found rope probably belong to fishing net which was observed floated on starboard side close to front of accommodation. Crew picked up the loose end of rope and tried to remove it but seems rope secured at bottom side by bottom anodes. Presently rope secured to deck. Planning to remove it by using work boat in next convenient port. Diameter of rope about 10 mm, loose end length about 5 meters. The distance from rope end to aft thrusters was about 10 m when loose rope was floating on water surface.

Follow Up								
On	Ву	Follow Up						
28/May/2023	Valentin MITENKOV Staff Code - 10552 - MST	One loose end of this fishing rope was connected with ship's messenger rope and secured on deck. At anchorage crew was using work boat pulling loose end of fishing rope with connected messenger into forward of vessel and put on mooring winch. Fishing rope was finally removed from bottom anode where it was stuck.
