Maritec Tanker Management

Near Miss Details

Vessel : Bitu River

Defect ID : 24

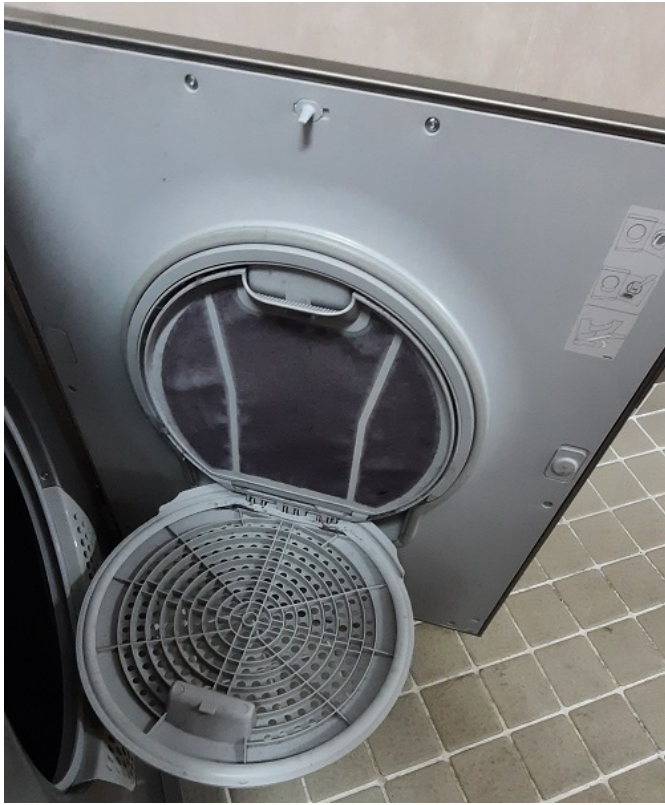
Before

The laundry room drying machine filter is not cleaned after operation which can be a fire hazard.

Lack of motivation to follow the proper procedures
