Maritec Tanker Management

Defect List Details

Vessel : Bitu Atlantic	Defect ID : 107	NCR # :	Is NCR ? : No
------------------------	-----------------	---------	---------------

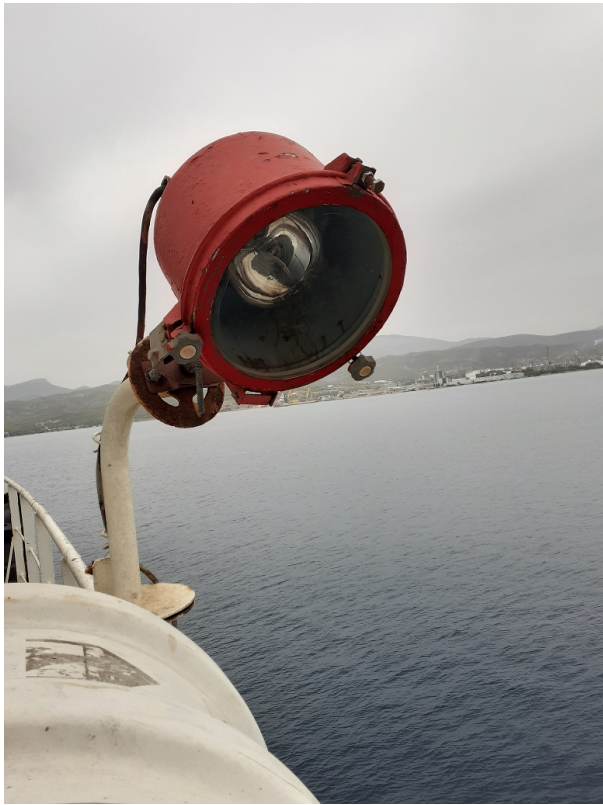
Emergency light for starboard Liferaft was not providing proper illumination. Upon further investigation it was observed that plastic sheet was wrapped on the cover which was obstructing the spread out of the entire flux.
