## Maritec Tanker Management

### Defect List Details

Vessel : Asphalt Teranga	Defect ID : 102	NCR # :	Is NCR ? : No
--------------------------	-----------------	---------	---------------

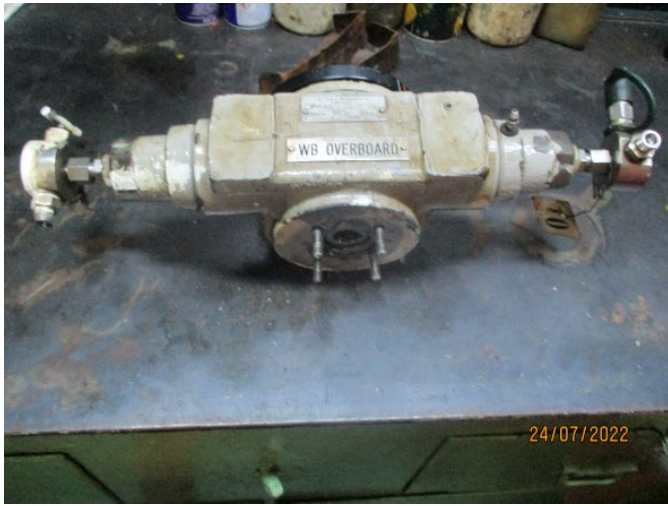
Ballast Pump Over Board Valve Actuator Found leaking.

On	By	Follow Up	
02/Aug/2022	Munna Kumar   Staff Code - 10065 - 2/E	Actuator open and overhauled with new o rings/seals fitted back tried out working satisfactory,
