## Maritec Tanker Management

### Defect List Details

Vessel : Bahama Blue	Defect ID : 180	NCR # : 3/2023	Is NCR ? : Yes
----------------------	-----------------	----------------	----------------

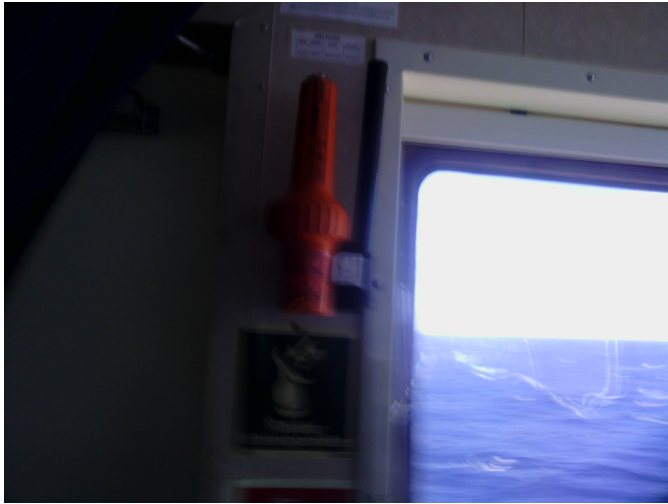
Before

During annual inspection by US Coastguard made deficiency Code 11122(SOLAS 20 III/6.2.2):  
On ships carrying at least two Search&Rescue locating devices and equipped with free fall life boats one of the search and rescue locating devices shall be stowed in the fre fall life boat. There was no search and rescue locating device stored in the free fall life boat.

Company procedure prescribed as per Muster list for 2nd Officer duties to bring SART into the fre fall life boat during emergency/drills.

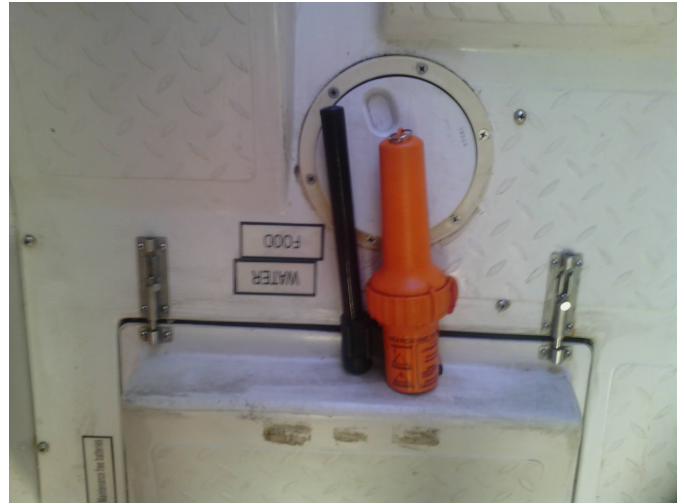
After

On	By	Follow Up	
09/Feb/2023	Valentin MITENKOV   Staff Code - 10552 - MST	SART located on the bridge assigned for 2nd Officer duties by muster list to bring this into life boat. SART was stowed in the fre fall life boat to satisfy requirements of US Coastguard.	<a href="#">Link1</a> <a href="#">Link2</a> <a href="#">Link3</a>

SART transferred and stowed into free fall life boat as per SOLAS regulation.
