Maritec Tanker Management Defect List Details

Vessel: Bitu Atlantic	Defect ID: 217	NCR # :	Is NCR ?: No

Brake support bolt below brake band, aft spring winch spacing excessive (12-15mm)

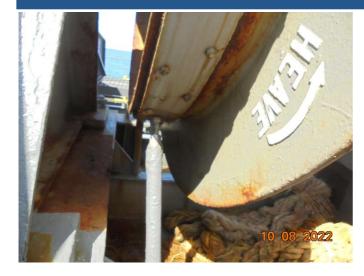
Before

PMS not followed

Support bolt adjusted to 3-4 mm
