Maritec Tanker Management

Defect List Details

Vessel : Bitu Atlantic	Defect ID : 269	NCR # :	Is NCR ? : No
------------------------	-----------------	---------	---------------

BWTS malfunction due to H2 gas sensor failure.

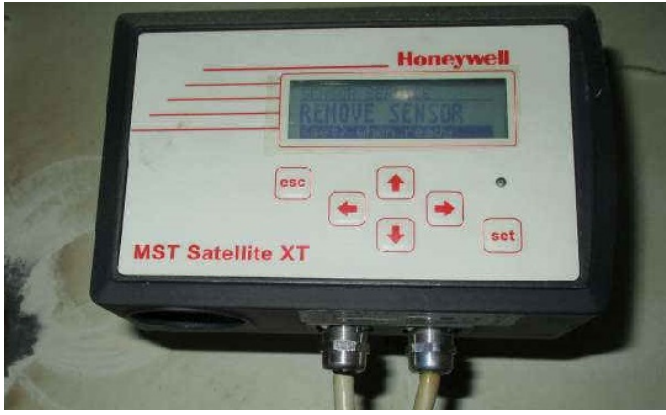
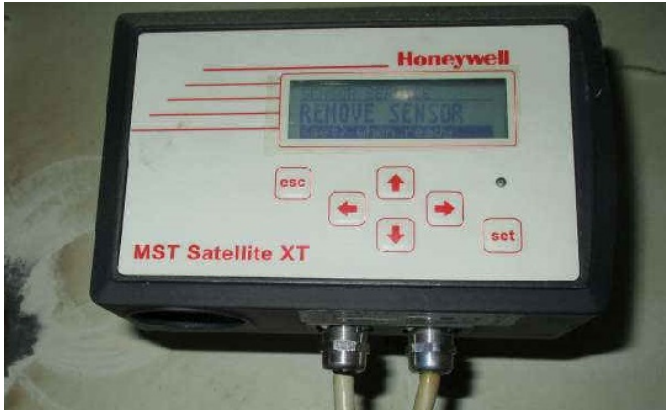
Before

Failure of H2 gas sensor.

Inform office
Earlier requisition raised
Ballast exchange carried out as per approved ballast water management plan

Keep H2 gas sensor as spare

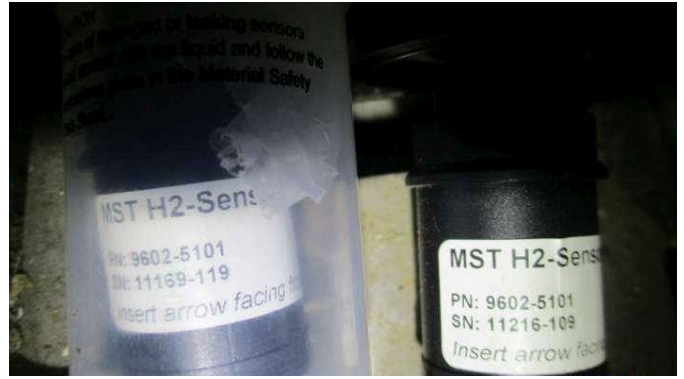
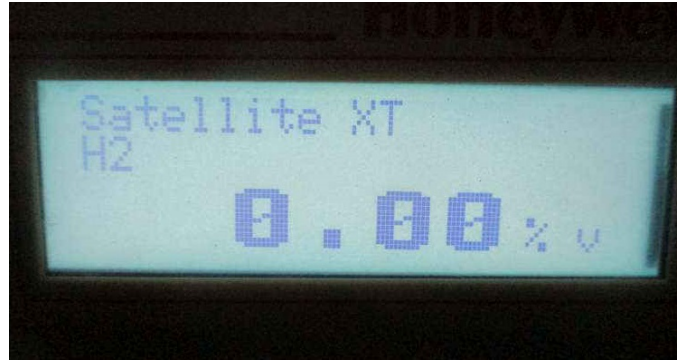
After

On	By	Follow Up	
22/May/2023	Vitaly Maslov Staff Code - 10565 - C/E	Sensor renewed.	
07/Mar/2023	Stelian BOGHEA Staff Code - 10166 - C/E	Requisition raised BATL-SOT-V220220 on 07Nov2022.
