Maritec Tanker Management Defect List Details

Vessel: Asphalt Teranga Defect ID: 44 NCR #: 1/2022 Is NCR ?: Yes

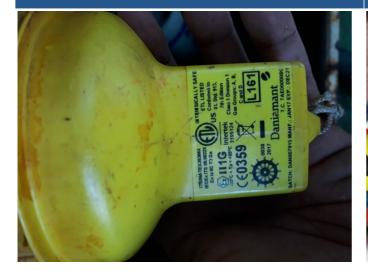
Before

Lifebuoy light at forecastle deck (S) was found expired.

Proper inspection not done.

Replaced with new one

Deligently following weekly checklist B.6.10 LSA/FFA.
