Maritec Tanker Management

Defect List Details

Vessel : Biskra	Defect ID : 99	NCR # :	Is NCR ? : No
-----------------	----------------	---------	---------------

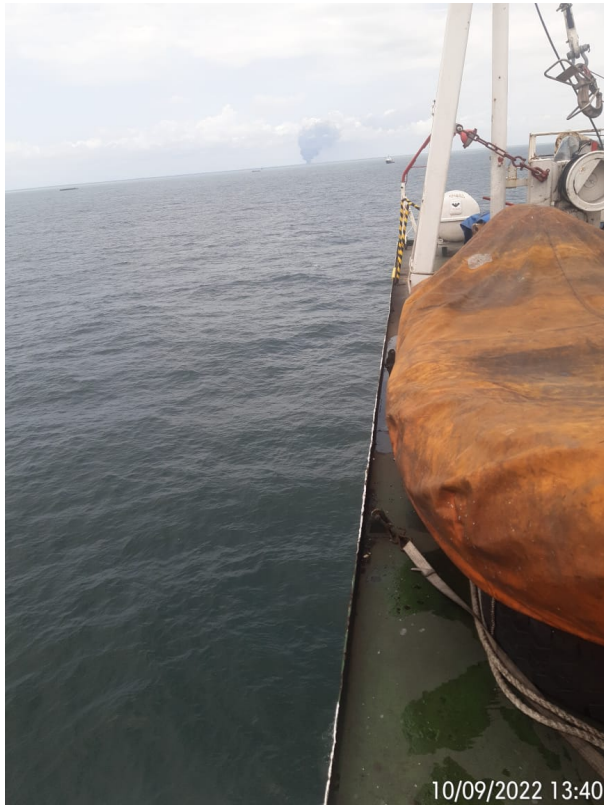
No Safety guard / Rope near Rescue boat / Life raft, very unsafe

Inadequate Guards or Barriers
