Maritec Tanker Management

Defect List Details

Vessel : Bitu Atlantic	Defect ID : 157	NCR # :	Is NCR ? : No
------------------------	-----------------	---------	---------------

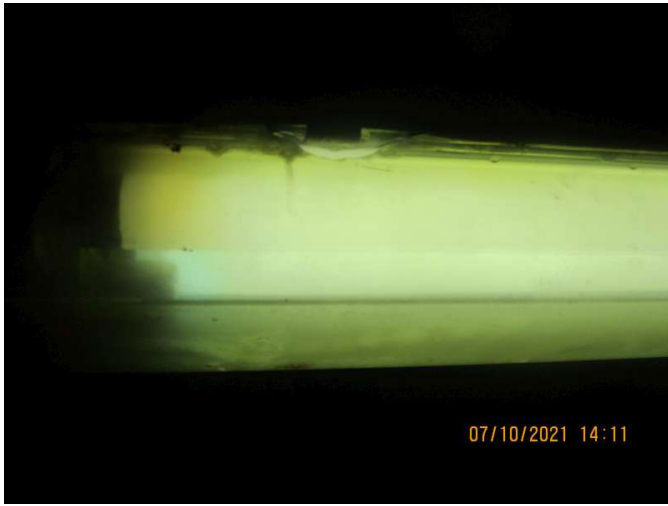
Light covers of following places are found broken - Pump room 2nd and 4th platform, E/R bottom platform - near emergency exit.

Wear and Tear (Not Related to Lack of Maintenance)

On	By	Follow Up	
09/Oct/2021	ANUJ KUMAR Staff Code - 10276 - E/O	Replaced broken cover in E/R. Pump room light covers not held in stock. Requisition ATLC-SOT-V210306	
05/Oct/2021	Nawin Khaware
