Maritec Tanker Management

Defect List Details

Vessel : Bitu Atlantic	Defect ID : 170	NCR # :	Is NCR ? : No
------------------------	-----------------	---------	---------------

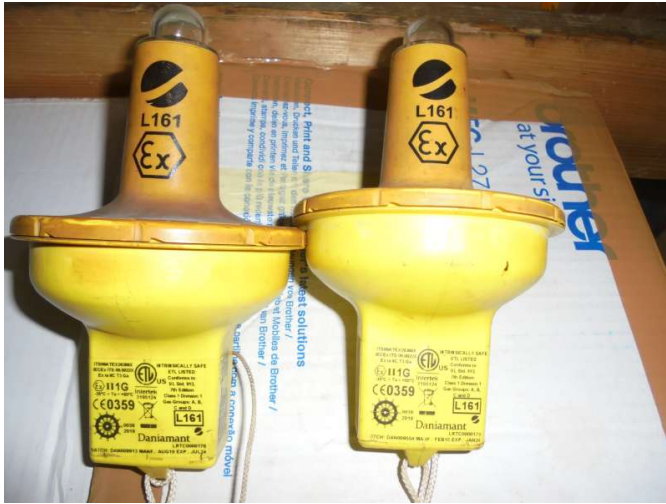
Before

Both side Gangway Lifebuoy S.I. Lights were not working properly, same was rectified by the attending officer once pointed out to him. However vessel should ensure a routine maintenance on LSA/FFA items are performed diligently and same must be verified by Senior officer during rounds.

On	By	Follow Up	
30/Oct/2021	Naeem Kalangadan Staff Code - 10375 - 3/OFF	checking every week properly all LSA AND FFA and record keeping properly . It will not repaat again	
05/Oct/2021	Nawin Khaware
