Maritec Tanker Management

Defect List Details

Vessel : Bitu Express	Defect ID : 307	NCR # :	Is NCR ? : No
-----------------------	-----------------	---------	---------------

Transfer Pump #2 FO for Main Engine and Generatators Coupling Shaft without cover protections.
Requisition Code :

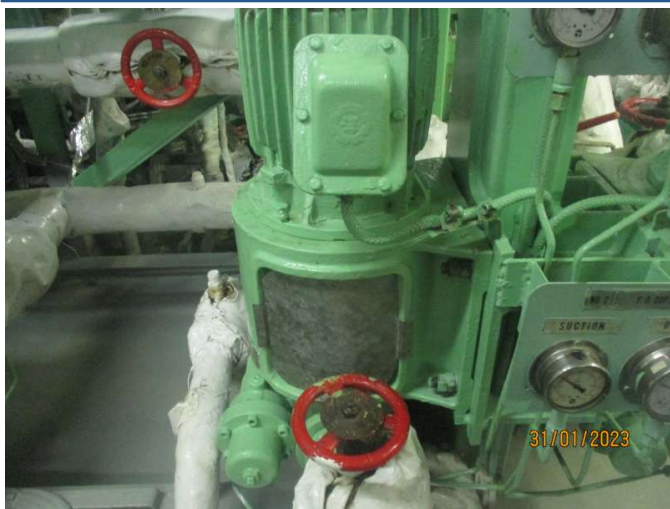
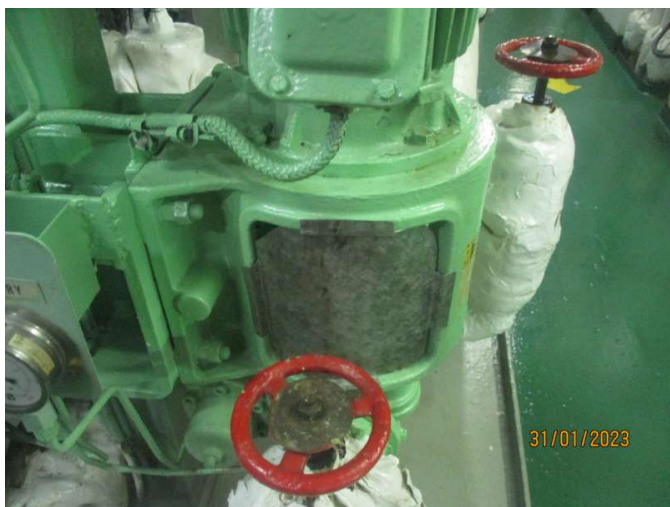
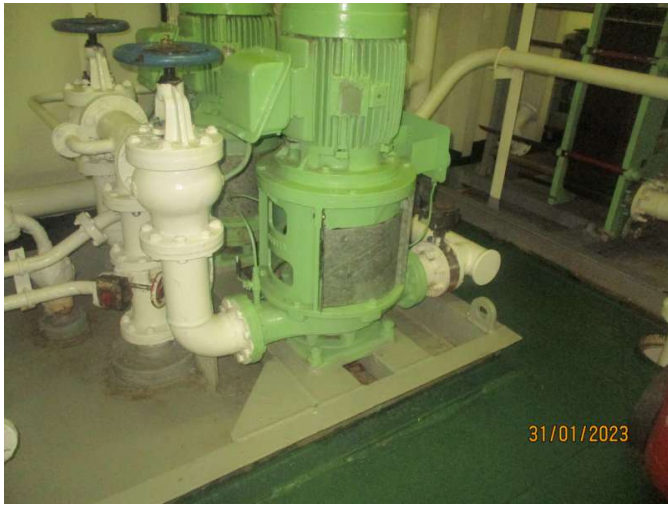
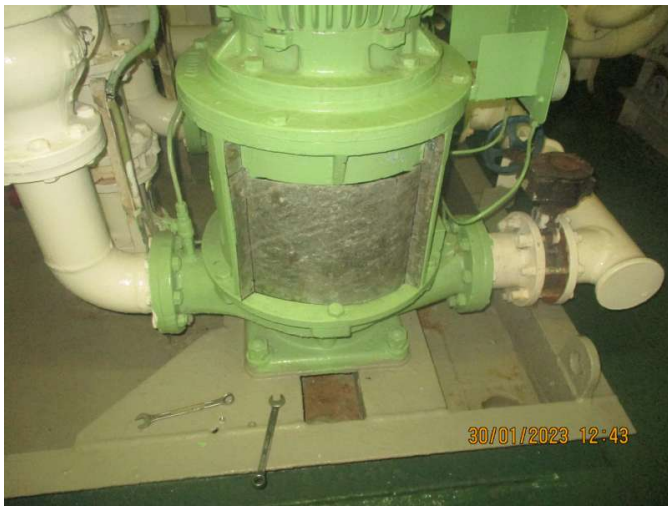
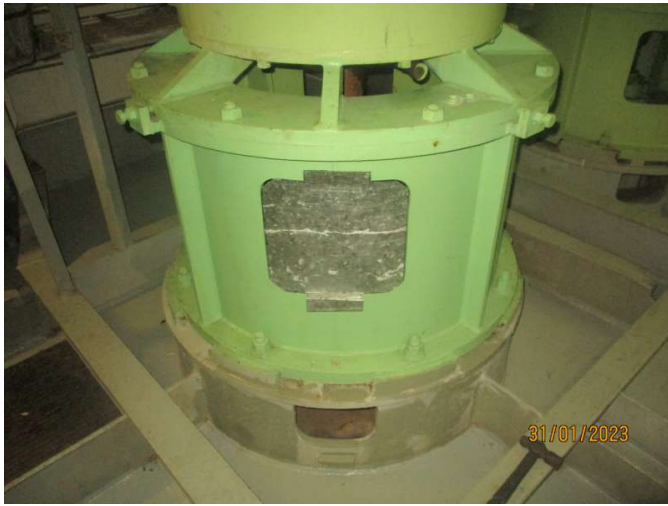
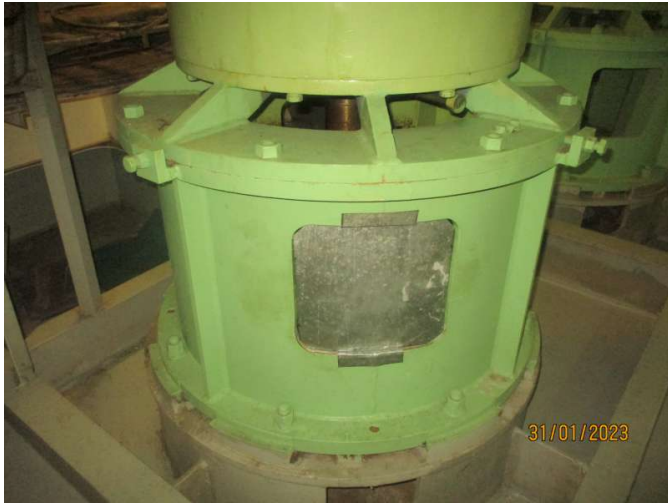
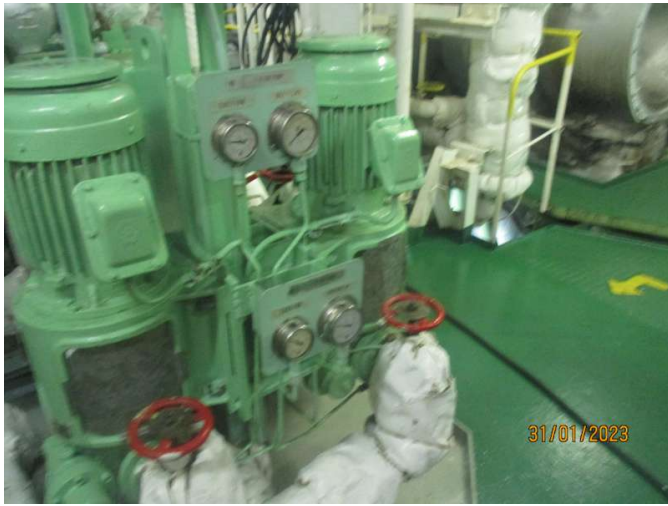
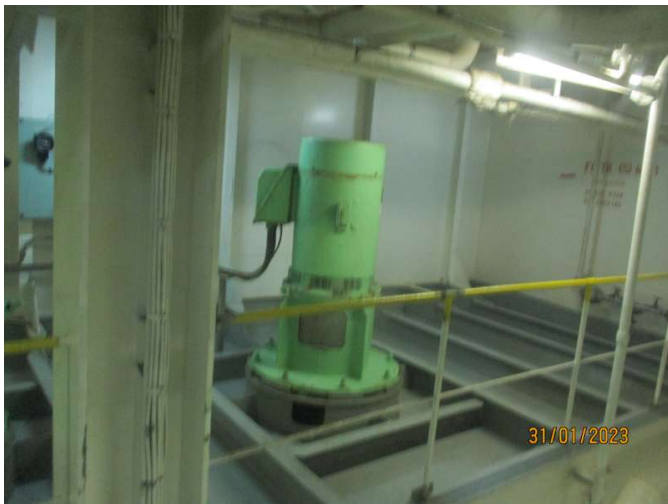
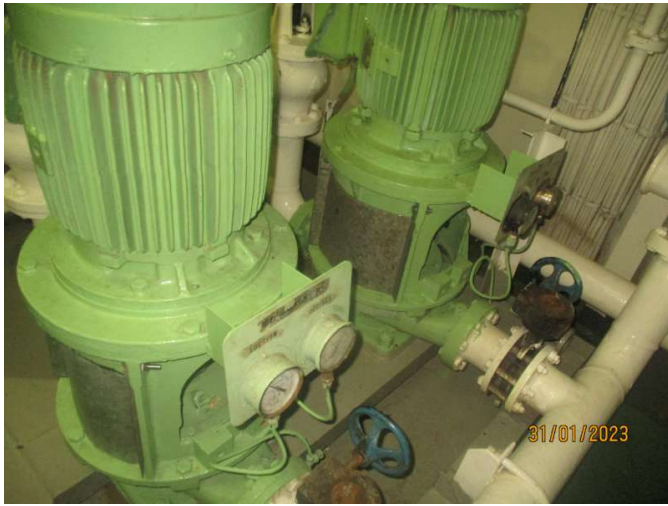
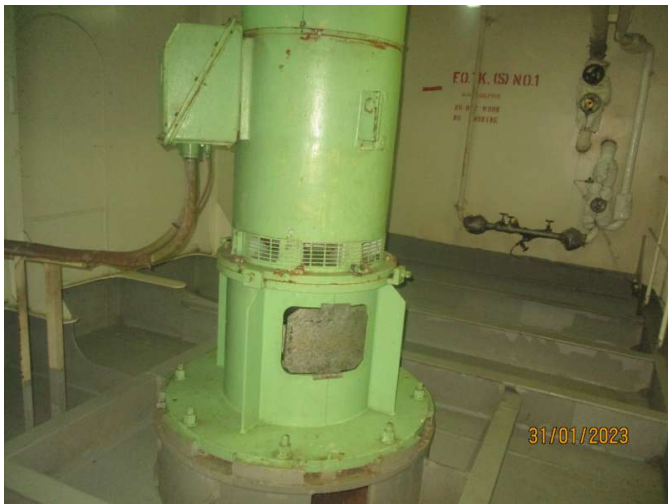
29/Jan/2023	Marin Panait Staff Code - 10017 - MST	Ship Design without Cover Protection. Vessel will fabricate on board this cover protections.	Link1 Link2 Link3 Link4 Link5 Link6 Link7 Link8 Link9 Link10 Link11
-------------	--	---	---
