Maritec Tanker Management

Defect List Details

Vessel : Bitu Express	Defect ID : 307	NCR # :	Is NCR ? : No
-----------------------	-----------------	---------	---------------

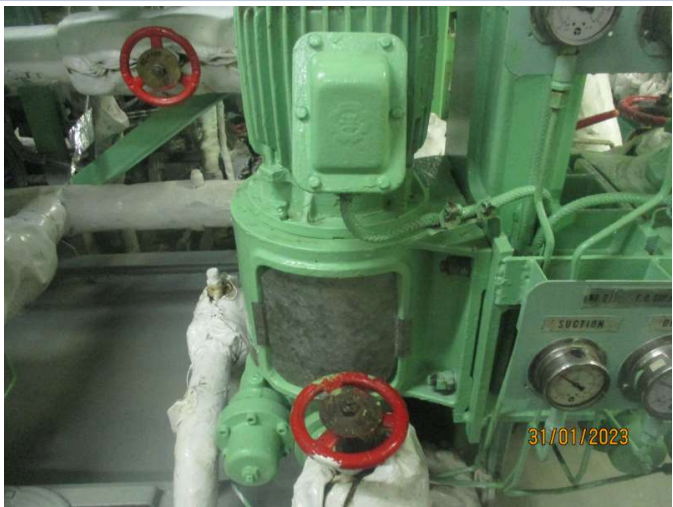
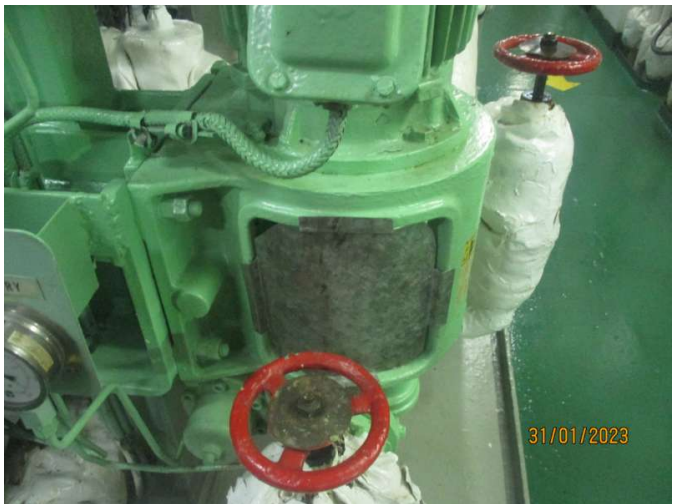
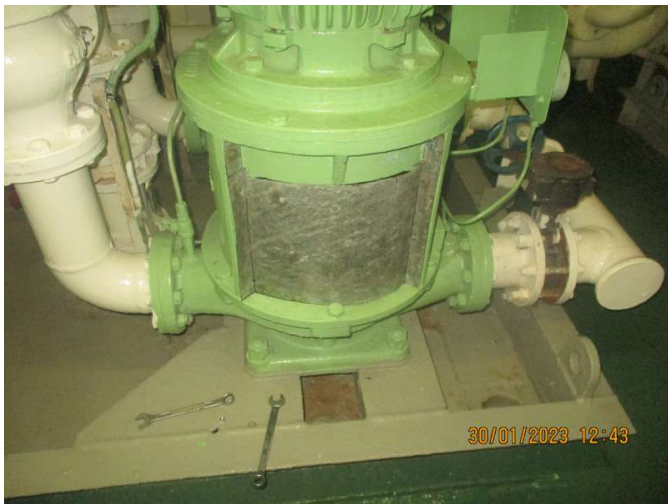
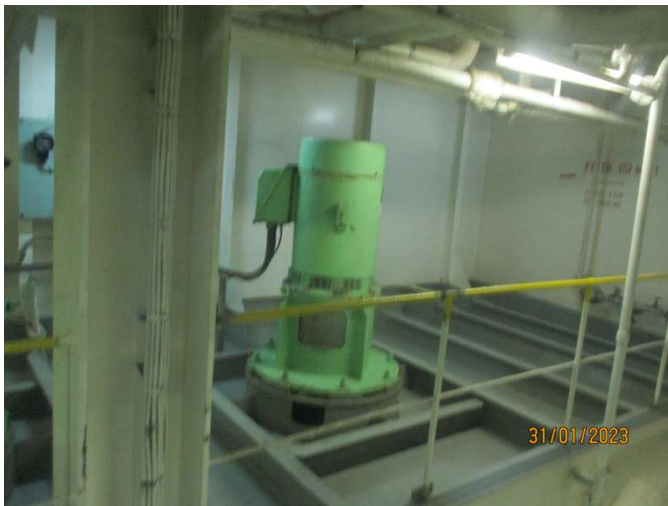
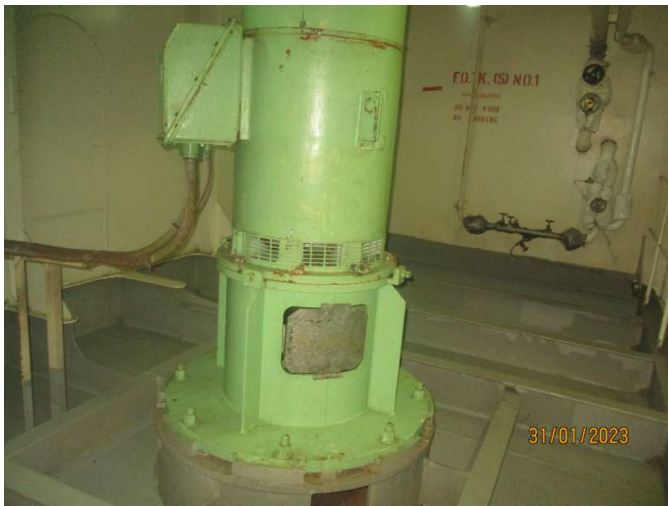
Transfer Pump #2 FO for Main Engine and Generatators Coupling Shaft without cover protections.

29/Jan/2023	Marin Panait Staff Code - 10017 - MST	Ship Design without Cover Protection. Vessel will fabricate on board this cover protections.	Link1 Link2 Link3 Link4 Link5 Link6 Link7 Link8 Link9 Link10 Link11
-------------	--	---	---
