Maritec Tanker Management

Defect List Details

Vessel : Bitu Atlantic	Defect ID : 137	NCR # :	Is NCR ? : No
------------------------	-----------------	---------	---------------

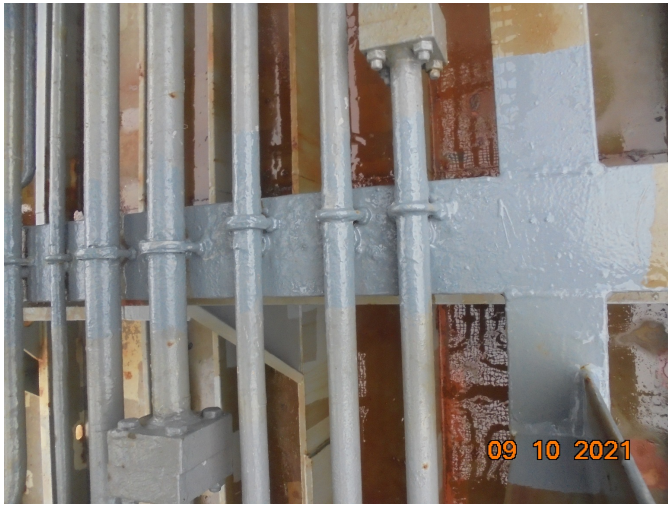
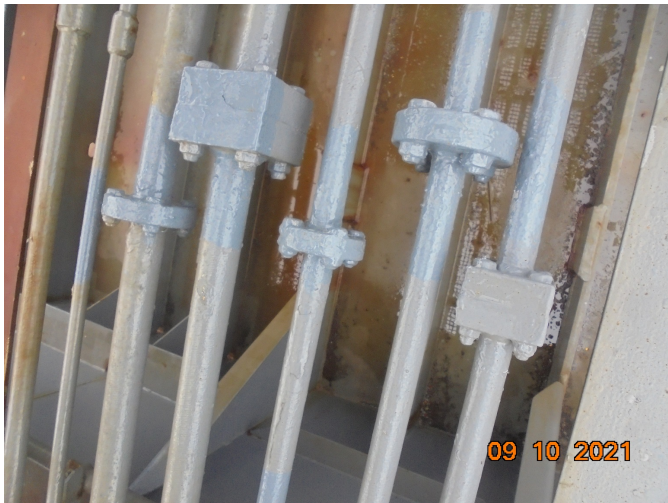
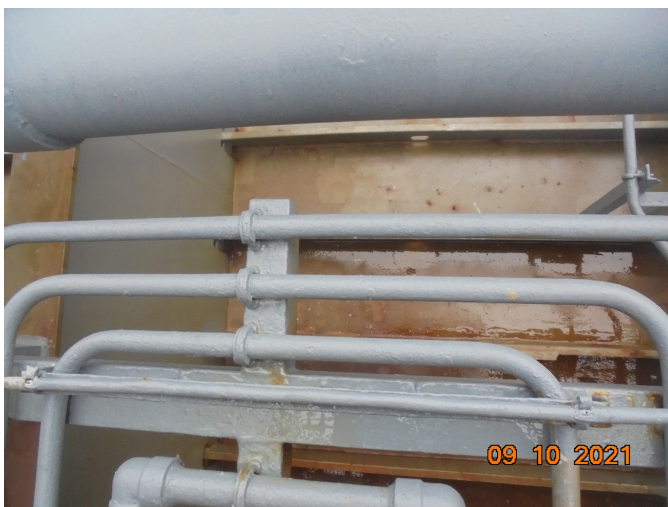
Before

Hydraulic pipe line showing signs of localised rusting same to be treated and entire length of hydraulic piping to wrap with DENSO tape
