Maritec Tanker Management Defect List Details

Vessel : Bitu Atlantic Defect ID : 150 NCR # : Is NCR ? : No	
---	--

Soot collection tank is in poor condition- maintenance required

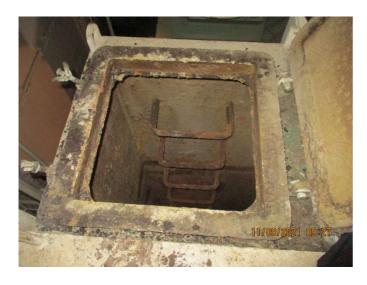
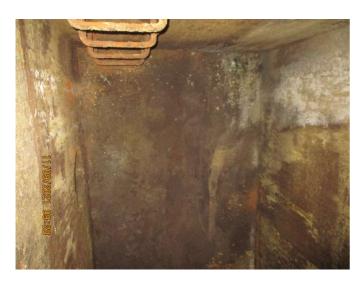
Before & After Pictures

Wear and Tear (Not Related to Lack of Maintenance)

On	Ву	Follow Up	
26/Sep/2021	Stelian BOGHEA - Staff Code - 10166 - C/E	Will be necessary to replace the bottom frame plate due to corrode.	
31/Aug/2021	Kamlesh Jalori
