MAINTENANCE BULLETIN: 18/001

Date: 06th December 2018

SUBJECT: Care, Maintenance, Inspection & Replacement of Mooring Ropes.

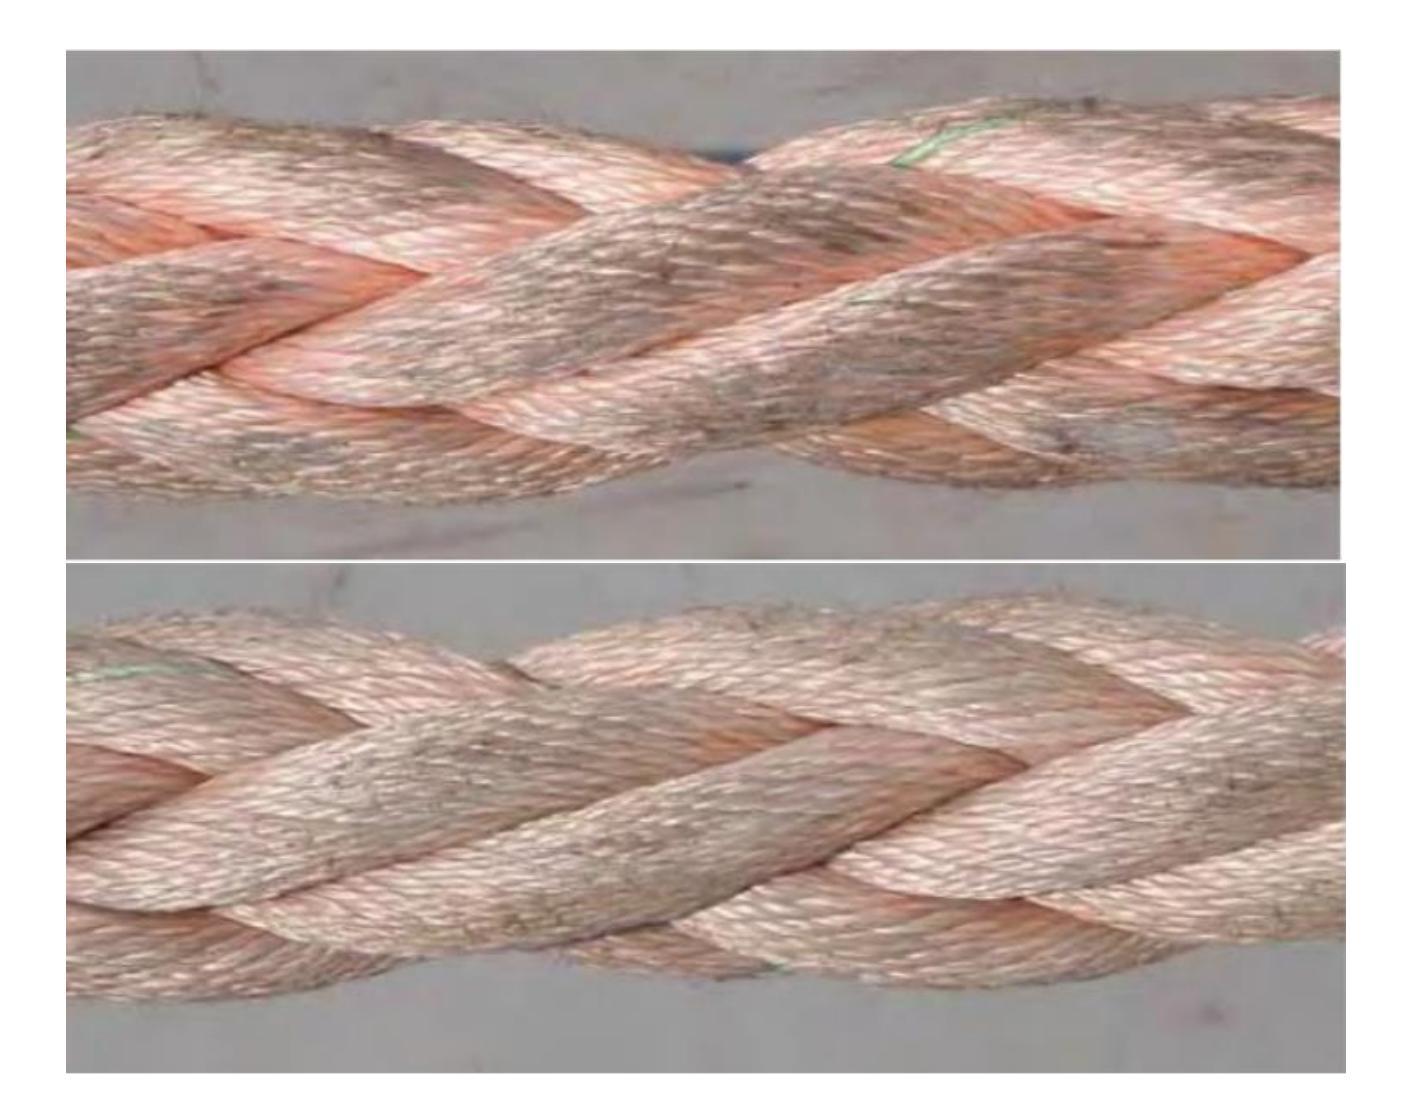
Category A - Residual Strength > 95%. The rope is relatively new with minor abrasion on the external surface. Minor fuzz is apparent in some places on the surface.

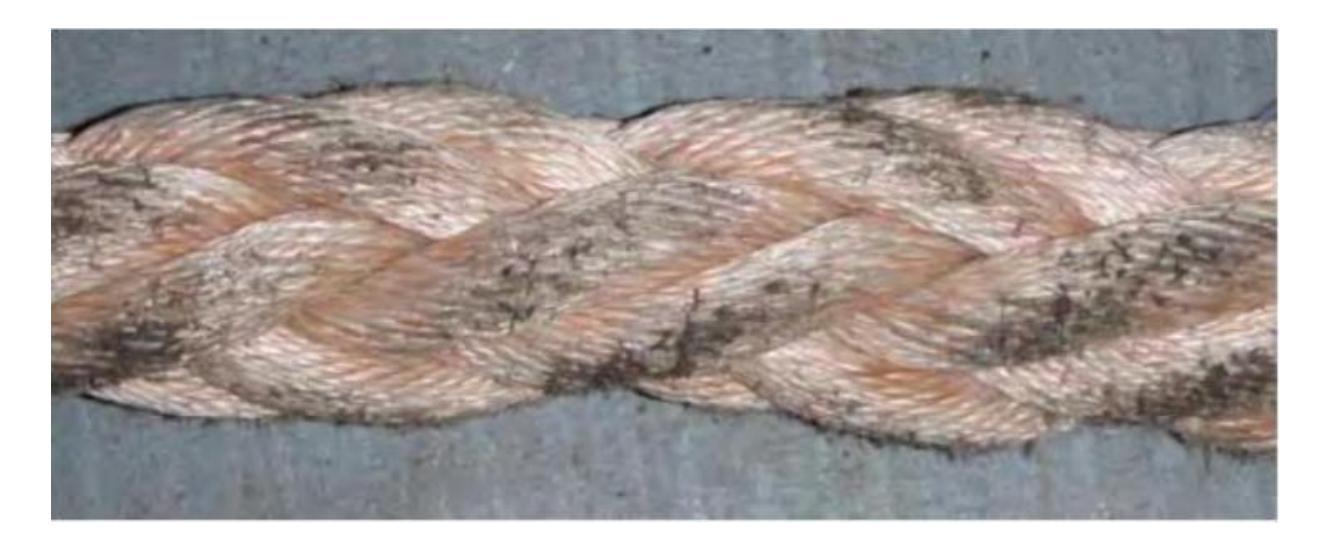
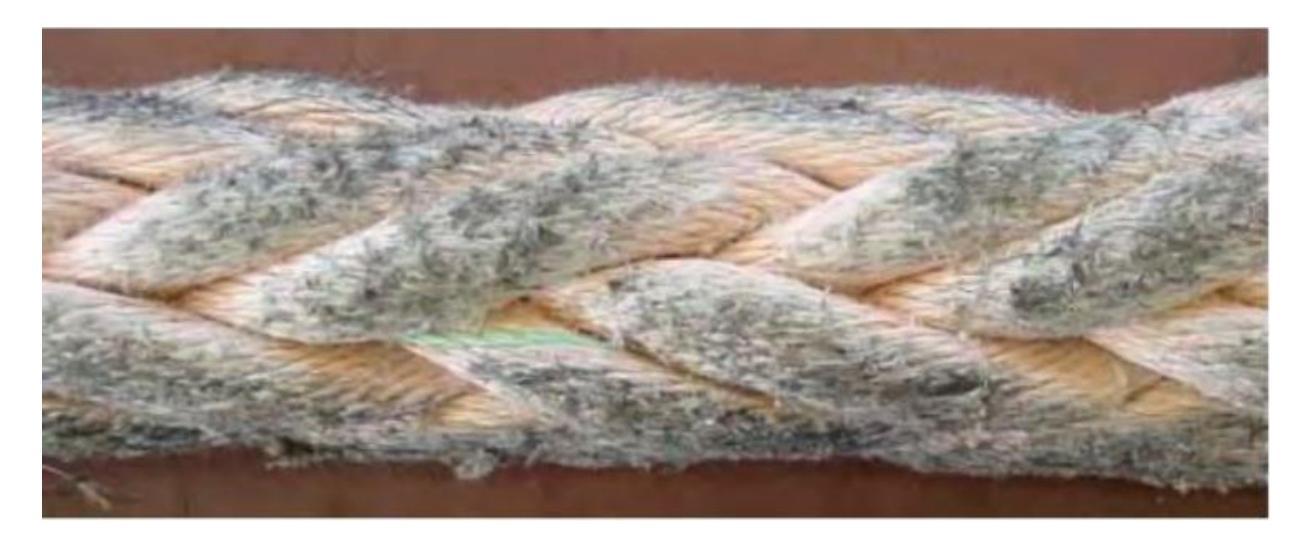
Category B - Residual Strength 85% - 88%. Noticeable abrasion all around. Slight fuzz on external surfaces. The rope is still strong and useable.

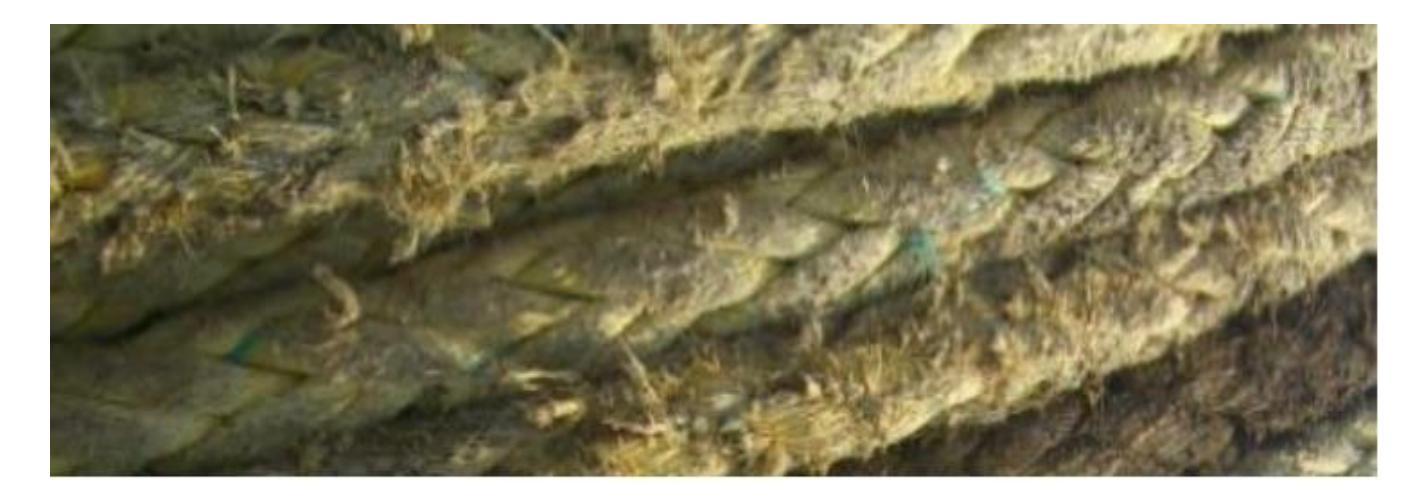
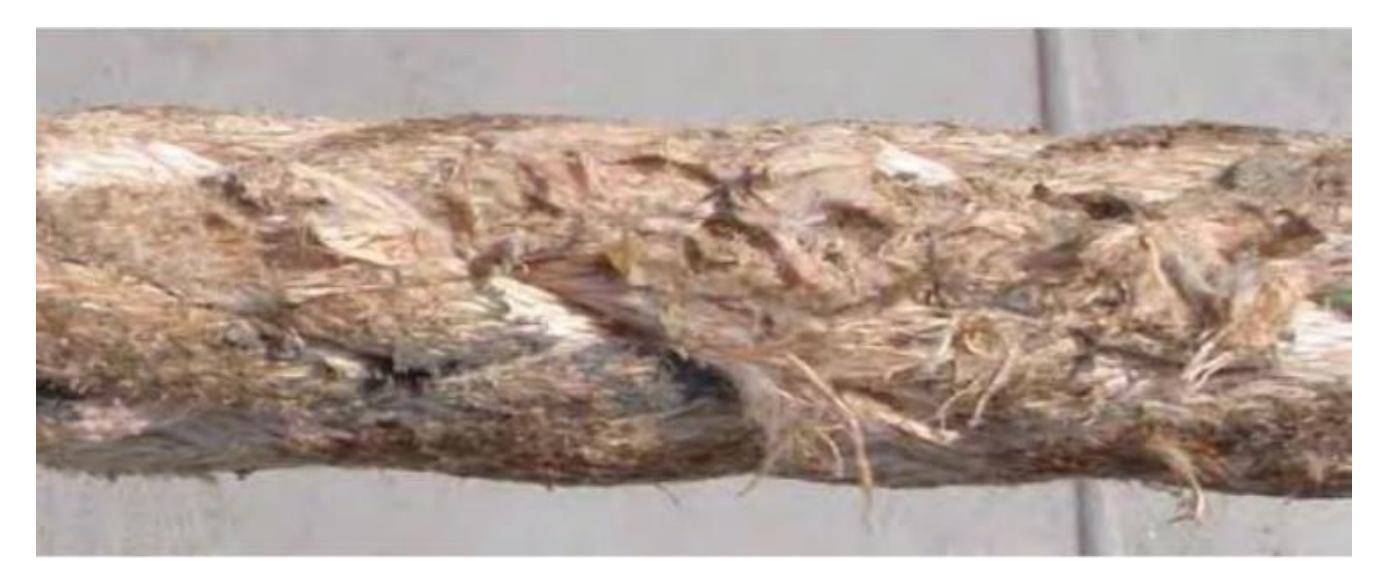
Category C - Residual Strength 75% - 80%. Fuzz all around internal and external surfaces. Up to 1/4th yarns on a strand are damaged due to chaffing. Consider changing end to end and monitor the condition closely.

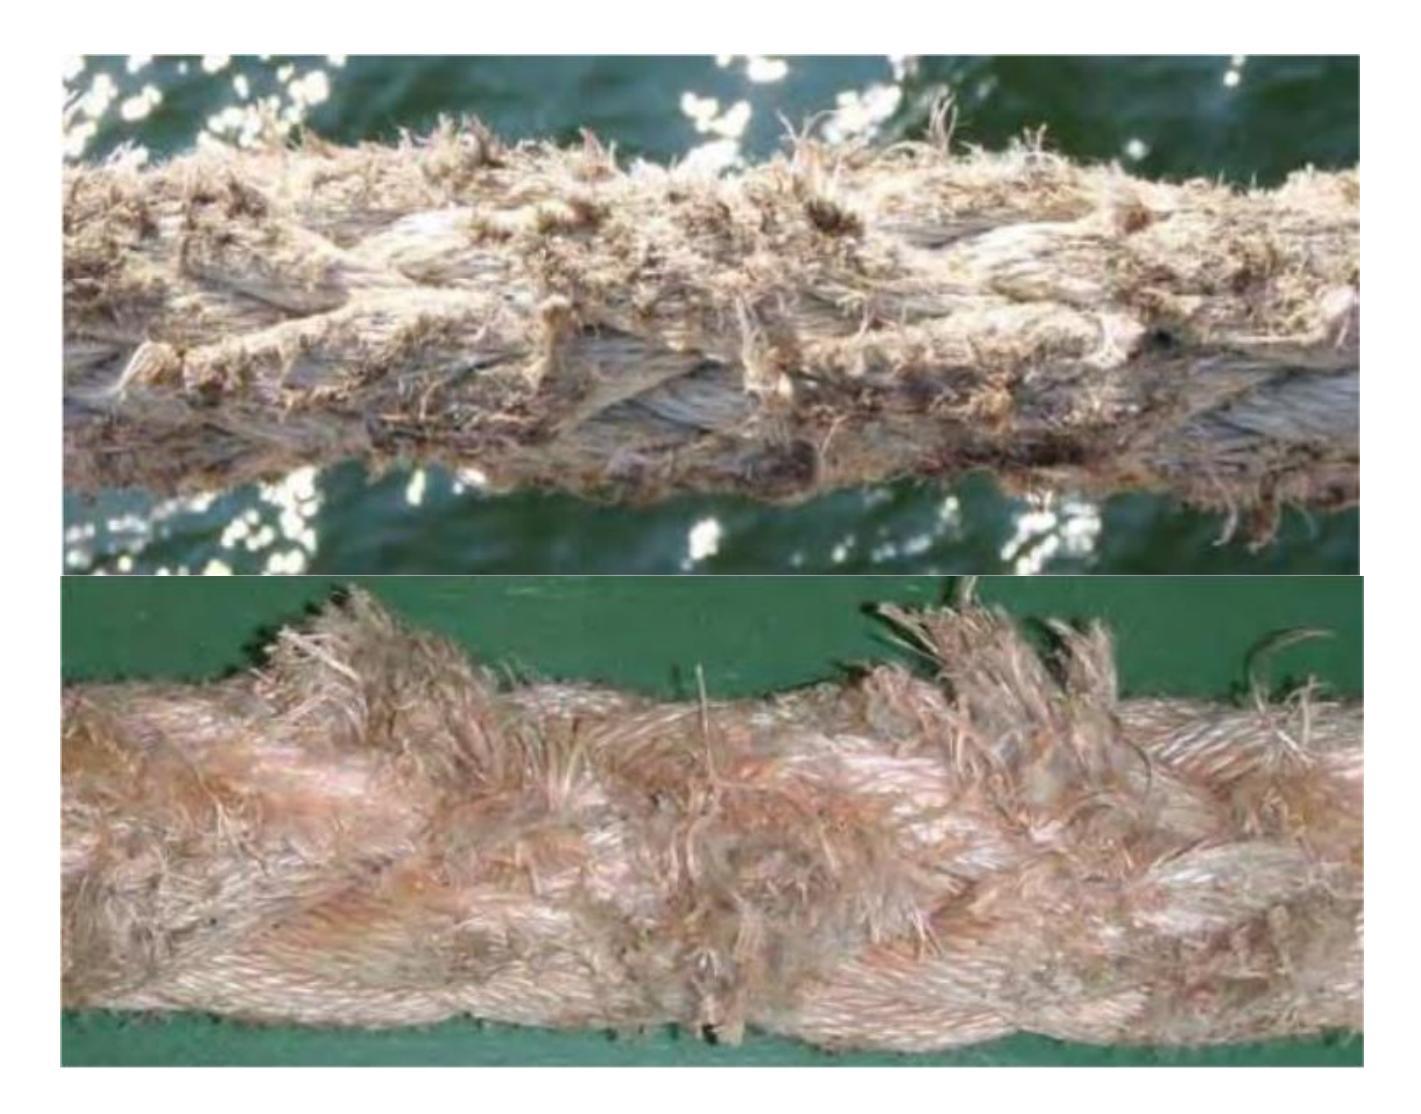
Category D - Residual Strength <75%. Significant abrasion and yarn damage along the length of the rope. 1/2 or more yarns are broken on a strand. The rope is likely to break at the area where the damage is maximum. This requires immediate replacement.

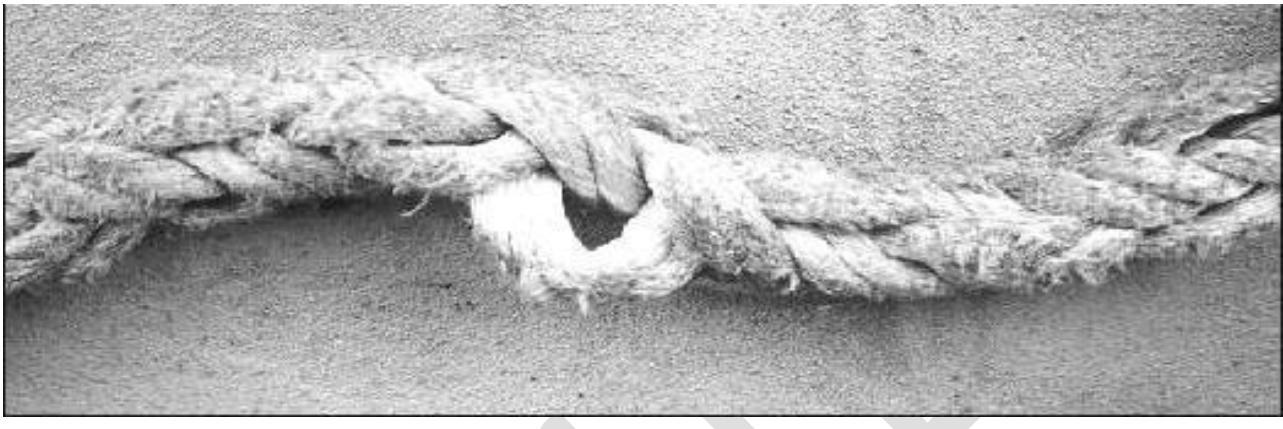
1. Pulled – out strand

Few more illustrations for reference where the ropes to be considered for replacement.

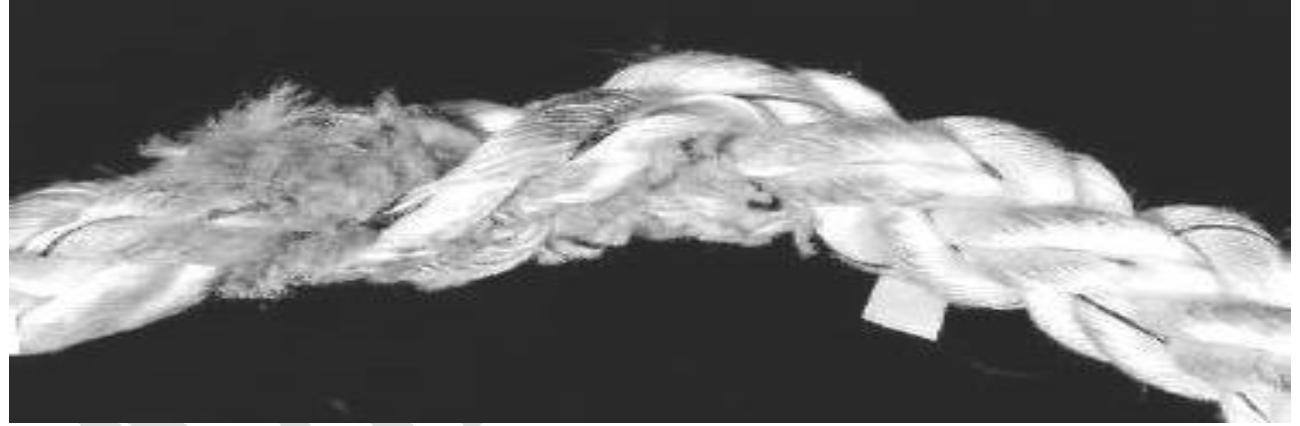
2. Cut Strand

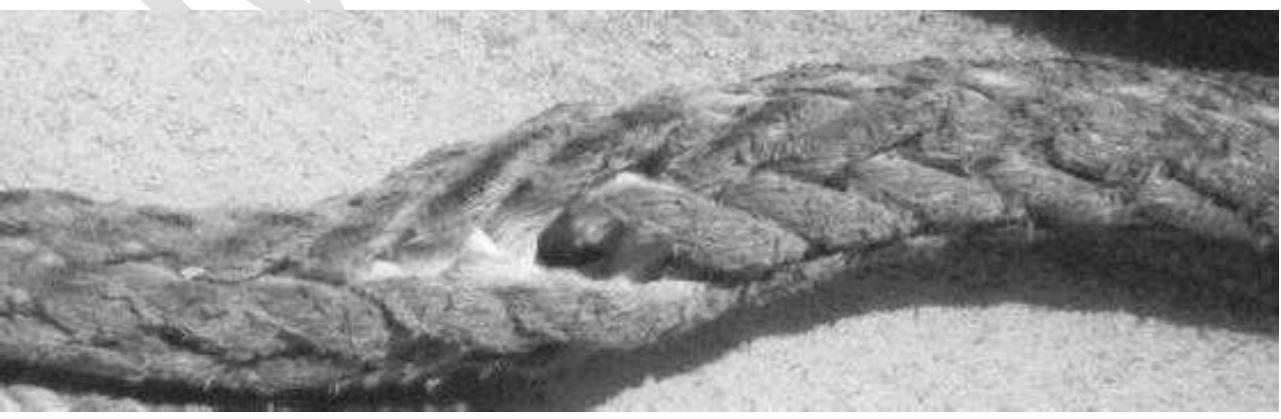
3. Glazed - Overheated
