## **TECHNICAL CIRCULAR**

**01/2023**

### **SUBJECT: Use of Silicon for Main Engine / Auxiliary Engine Overhauling**

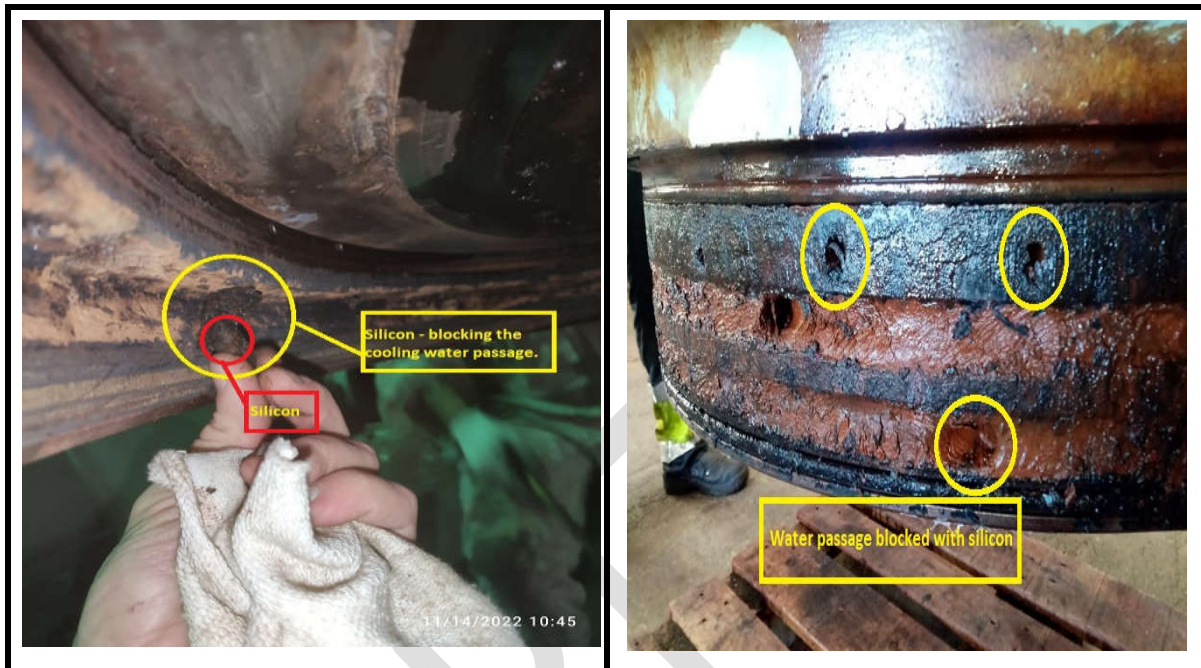
The Cooling Water Temperature was higher as compared with other units of the Engine. When this unit was opened for overhaul, it was observed that the Cooling Water spaces were clogged with silicon, thereby restricting the flow of water, resulting in higher temperature.

During the previous overhaul, ship staff had installed all the O-rings of Cylinder Head and Exhaust valve, by using excessive Silicon sealant. This excessive sealant had found its way through the Cooling water passage, thereby clogging the Cooling water openings, and resulting in the restriction to Cooling water flow.

All the fleet vessels are advised to use Maker recommended lubricants for O rings, like Lithium base grease/Silicon grease /Swarfega hand cleaner during any Engine overhaul (Main Engines/Aux engine) to avoid similar incidents in future.
